# OMAP-L132 C6000™ DSP+ARM® Processor Silicon Revisions 2.3, 2.1

## Silicon Errata

Literature Number: SPRZ317G  
August 2011–Revised March 2014

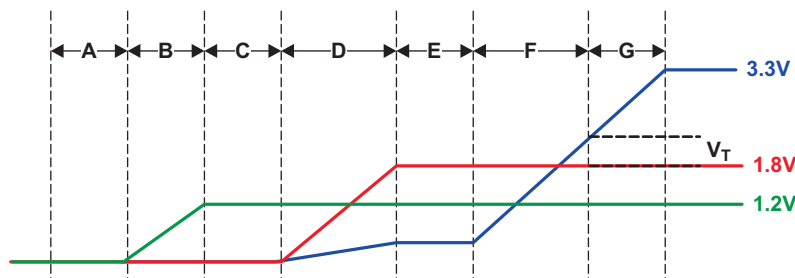
**Figure 5. Normal power-supply ramp**

- A. All device supplies are undriven
- B. The 1.2V supplies are ramped to their nominal levels
- C. Potential delay between supply ramps (not required)
- D. The 1.8V supplies (specifically DVDD18) are ramped to their nominal levels. During the DVDD18 ramp there will be some minor drift up in the undriven DVDD3318\_x supplies. This is normal and is not a problem.
- E. Potential delay between supply ramps (not required)
- F. DVDD3318\_x is ramping but is less than DVDD18 +  $V_T$
- G. DVDD3318\_x is ramping but is greater than DVDD18 +  $V_T$

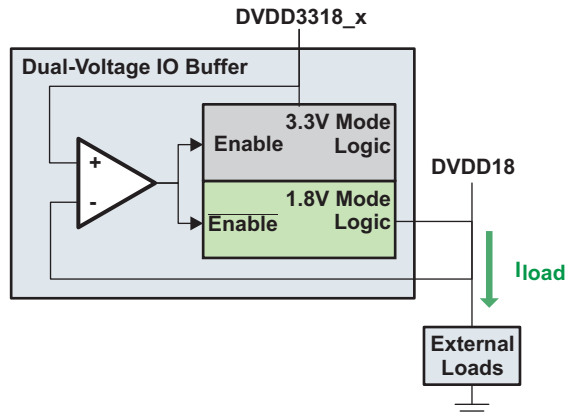
The condition occurs because the dual-voltage IO buffers have voltage detection circuitry that monitors DVDD3318\_x during reset and determines whether the applied supply voltage is 1.8V or 3.3V. This detection circuitry then configures the IOs to operate at the appropriate voltage. As the DVDD3318\_x supply ramps, there is a small range near DVDD18 +  $V_T$  where the voltage detection circuit finds the state indeterminate and briefly turns on circuitry associated with both voltage options creating a current path between them. This current path can cause the DVDD18 supply to be pulled up. The mechanism for this behavior is explained below:

#### Behavior of the IO buffer during Zone F:

As the DVDD3318\_x supply ramps, but is not yet one  $V_T$  above the DVDD18 supply, the comparator enables the 1.8V mode logic section and disables the 3.3V mode logic section. No unexpected current flows between the two sections.
