## PIC16F627A/628A/648A Rev. A Silicon/Data Sheet Errata

The PIC16F627A/628A/648A parts you have received conform functionally to the Device Data Sheet (DS40044F), except for the anomalies described below.

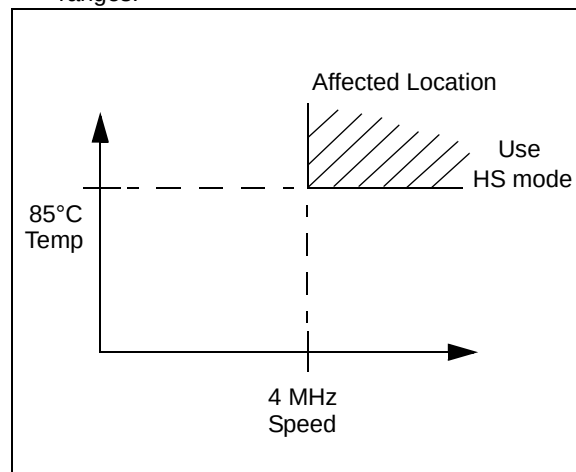
1. PIC16F648A Silicon Rev. A1.

When using the EC OSC mode at frequencies >4 MHz and temperatures >85°C, the part may execute incorrectly from the program memory, causing malfunction.

This problem only affects E-temp parts. Industrial grade parts are unaffected. HS mode should be used for frequencies >4 MHz at extended temps. All other clock modes work to their specified ranges.

**Note:** This problem is corrected in PIC16F648A Rev. A3. (Date code 0420XXX and later.)
