## PIC16F88X Family Silicon Errata and Data Sheet Clarification

The PIC16F88X family devices that you have received conform functionally to the current Device Data Sheet (DS41291G), except for the anomalies described in this document.

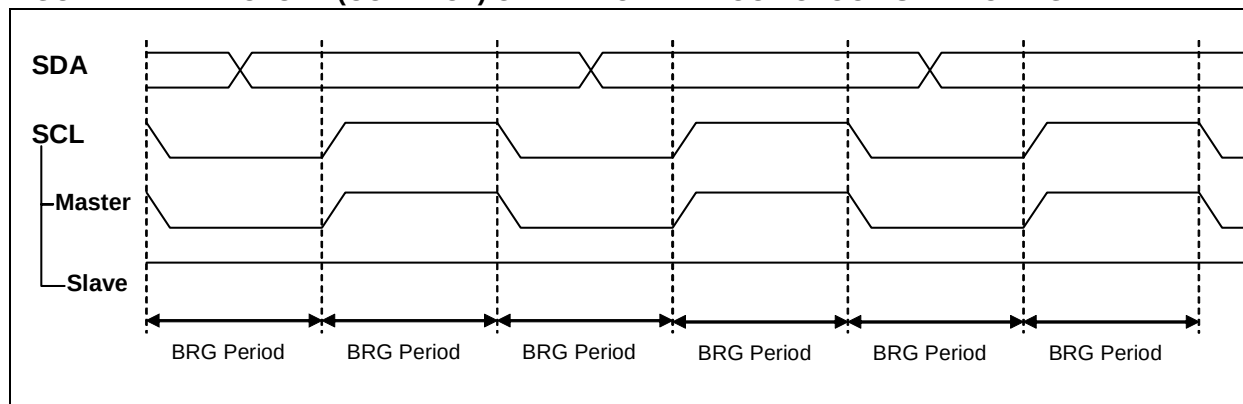
**FIGURE 1: ACTUAL (CORRECT) OPERATION WITHOUT CLOCK STRETCHING**

Figure 1 illustrates an expected I<sup>2</sup>C transmission in which the SCL line is completely controlled by the master device and the slave device does not attempt to stretch the clock period.

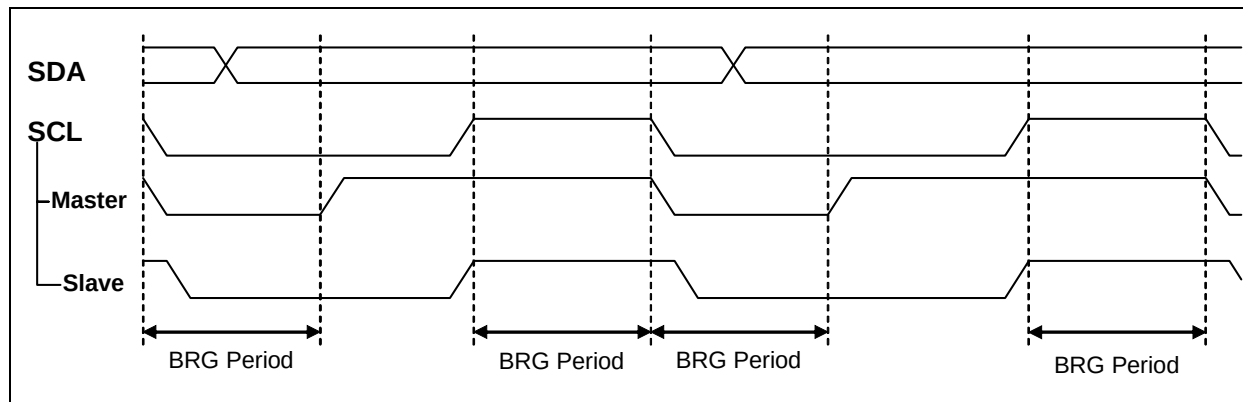
**FIGURE 2: EXPECTED OPERATION WITH CLOCK STRETCHING**

Figure 2 illustrates the expected operation of an I<sup>2</sup>C transmission in which the slave device has stretched the clock period by holding the SCL line low. The high time of the SCL pulse is constant, regardless of the duration of the clock stretch.
