# **TMS320C6748 Fixed- and Floating-Point DSP Silicon Revisions 2.3, 2.1, 2.0, 1.1 and 1.0**

## **Silicon Errata**

Literature Number: SPRZ303H  
June 2009–Revised March 2014

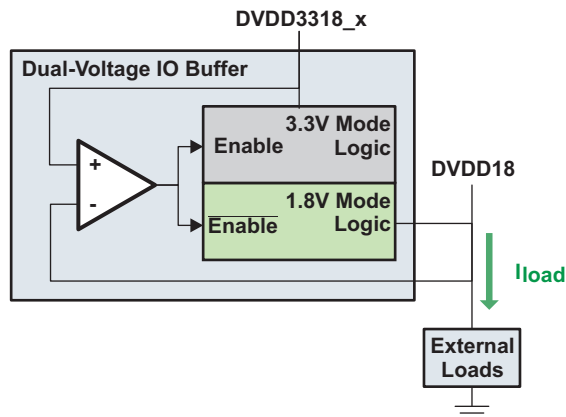
**Behavior of the IO buffer during Zone F:**

The condition occurs because the dual-voltage IO buffers have voltage detection circuitry that monitors DVDD3318\_x during reset and determines whether the applied supply voltage is 1.8V or 3.3V. This detection circuitry then configures the IOs to operate at the appropriate voltage. As the DVDD3318\_x supply ramps, there is a small range near DVDD18 +  $V_T$  where the voltage detection circuit finds the state indeterminate and briefly turns on circuitry associated with both voltage options creating a current path between them. This current path can cause the DVDD18 supply to be pulled up. The mechanism for this behavior is explained below:

As the DVDD3318\_x supply ramps, but is not yet one  $V_T$  above the DVDD18 supply, the comparator enables the 1.8V mode logic section and disables the 3.3V mode logic section. No unexpected current flows between the two sections.

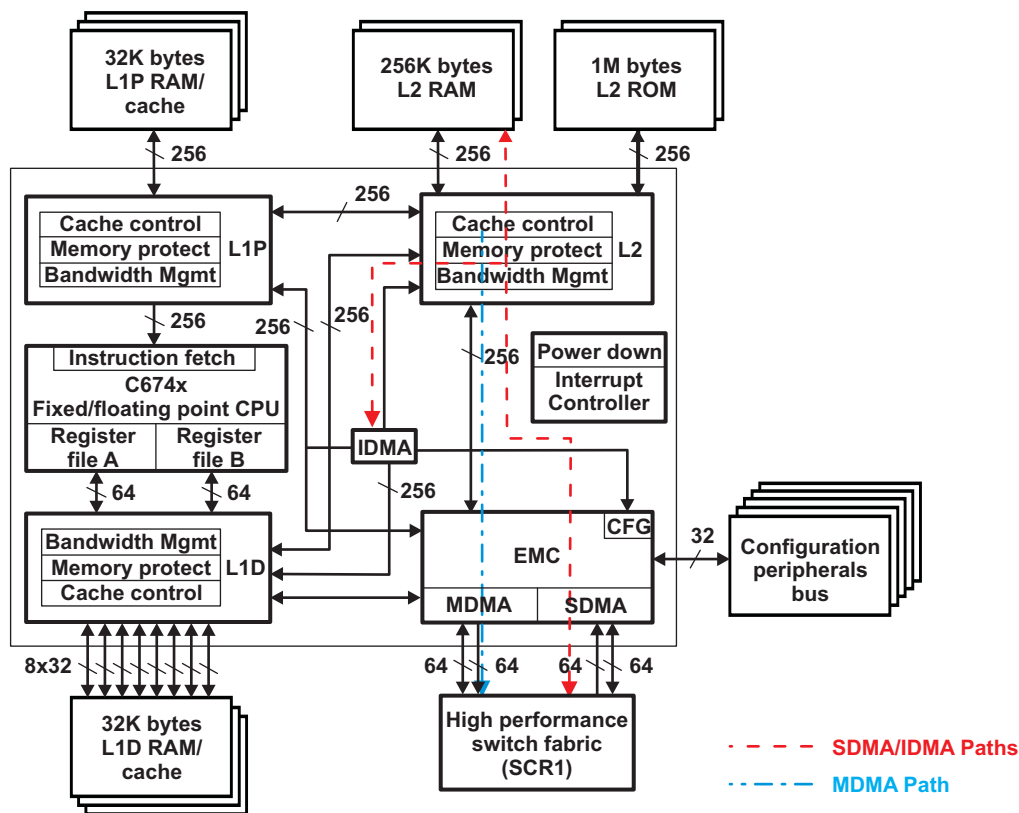
Figure 14. C674x Megamodule

Ideally, the MDMA (dashed-dotted line in Figure 14) and SDMA/IDMA paths (dashed lines in Figure 14) operate independently with minimal interference. Normally MDMA accesses may stall for extended periods of time due to expected system level delays (for example, bandwidth limitations). However, when using L2 as RAM, SDMA and IDMA accesses to L2/L1 may experience unexpected stalling in addition to the normal stalls seen by the MDMA interface. For latency-sensitive traffic, the SDMA stall can result in missing real-time deadlines. In a more severe case, the SDMA stall can produce a deadlock condition in the device. An IDMA stall cannot produce a deadlock condition.

**Note:** SDMA/IDMA accesses to L1P/D will not experience an unexpected stall if there are no SDMA/IDMA accesses to L2. Unexpected SDMA/IDMA stalls to L1 happen only when they are pipelined behind L2 accesses. Additionally, the deadlock scenario will be avoided if there are no SDMA accesses to L2.

Figure 14 is provided for illustrative purposes and is incomplete because of simplification. The IDMA/SDMA (dashed-lines) path could also go to L1D/L1P memories, and IDMA can go to DSP CFG peripherals. MDMA transactions can originate also from L1P or L1D through the L2 controller or directly from DSP).

The duration of the SDMA/IDMA stalls depend on the quantity/characteristics of the L1/L2 cache and the MDMA traffic in the system. Therefore, it is difficult to predict if stalling will occur and for how long.
