## XC3S1000 and XC3S1000L FPGA Errata and Deviations from Spartan-3/3L Data Sheet

DS099-E05 (v2.5) December 14, 2006

Errata Notice

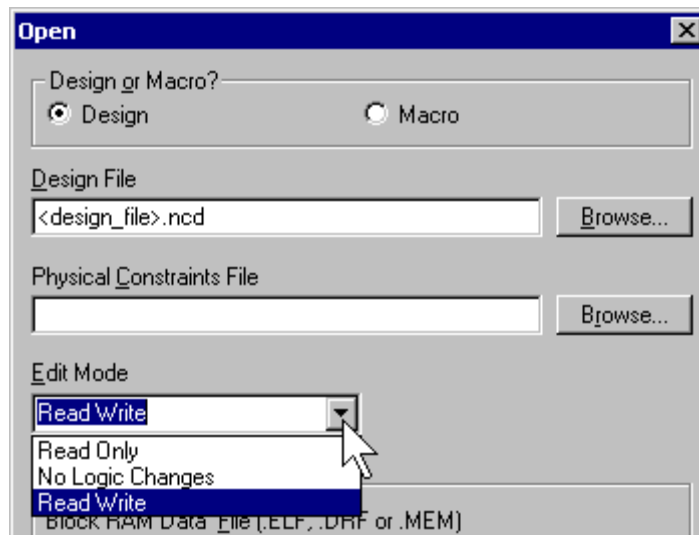
**Figure 6: Enable User Editing in FPGA Editor**

Without using the optimal settings, the DCM could potentially, with low probability, fail to assert the LOCKED output, could lose lock, or could produce erroneous clock outputs.

If the design is complete, with no further edits planned, then FPGA Editor offers the easiest method to update the FACTORY\_JF setting.

- Invoke the FPGA Editor. On Windows PCs, select **Start → Xilinx ISE 6 → Accessories → FPGA Editor**.
- Select **File → Open**. Select the \*.ncd file for the completed design. Set the **Edit Mode** to “Read Write” mode as shown in [Figure 6](#).
