## XC3S1500 and XC3S1500L FPGA Errata and Deviations from Spartan-3 FPGA Data Sheet

EN089 (DS099-E06) (v2.6) June 24, 2008

Errata Notice

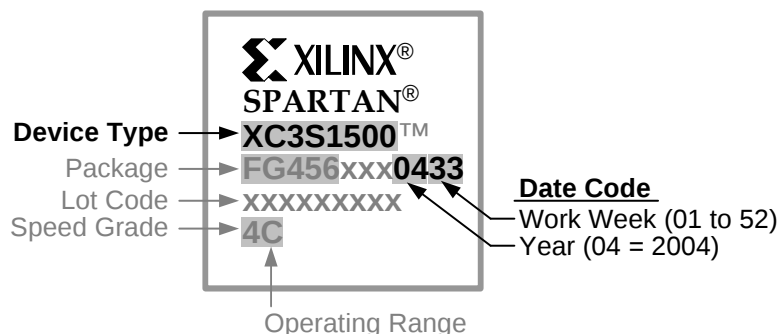
Figure 5: Example Spartan-3 Device Package Markings

These new bitstream settings are now the default settings starting with Xilinx ISE 6.3i, Service Package 1, available for download from the Xilinx web site after September 13, 2004. XC3S1500 FPGAs are tested using these new bitstream settings beginning with date codes “0433”, corresponding to Work Week 33 of 2004. [Figure 5](#) shows an example top marking for a Spartan-3 FPGA. The relevant fields to identify an affected device are highlighted and include the **Device Type** and the **Date Code**.

Please regenerate any Spartan-3 FPGA configuration bitstreams created using software versions prior to Xilinx ISE 6.3i development software, Service Pack 1. By updating the bitstream, the application can use any existing or future production Spartan-3 FPGA device.
