These errata apply **ONLY** to Spartan-3 XC3S200 FPGAs, including both production devices and engineering samples. These errata **DO NOT** apply to any other Spartan-3 FPGA. If using a different Spartan-3 FPGA, check for errata specific to that device.

These errata only apply to the XC3S200 FPGA as shown in [Table 1](#). Both engineering sample (ES) and production silicon (no ES marking) are affected. The [errata details](#) may further limit the class of devices affected by a specific issue.

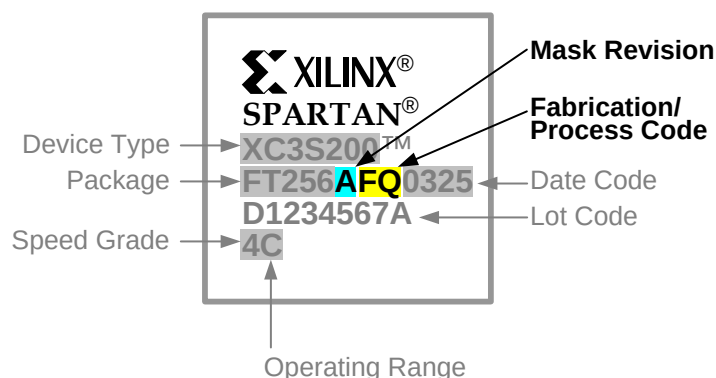
Figure 1: Spartan-3 FPGA from UMC 200 mm facility with “FQ” Fabrication/Process Code Marking

This issue only affects the XC3S200 FPGAs shown in [Table 4](#), marked with the “AFQ” mask/fabrication/process code as shown in [Figure 1](#).

This issue only affects the XC3S200 FPGAs shown in [Table 6](#), marked with the “AFQ” mask/fabrication/process code as shown in [Figure 1](#).

This issue only affects the XC3S200 FPGAs shown in [Table 7](#), marked with the "AFQ" mask/fabrication/process code as shown in [Figure 1](#).

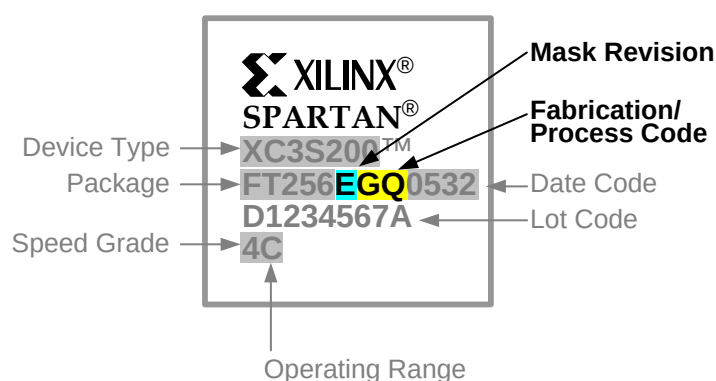
Figure 2: Spartan-3 FPGA from UMC 300 mm facility with “GQ” Fabrication/Process Code Marking

This issue is corrected on XC3S200 FPGAs with a “BGQ” mask/fabrication/process code marking, as shown in [Figure 2](#).

This issue is corrected on XC3S200 FPGAs with a “BGQ” fabrication/process code marking, as shown in [Figure 2](#).

This issue is corrected on XC3S200 FPGAs with a "BGQ" fabrication/process code marking, as shown in [Figure 2](#).

This issue only applies to those designs using the Readback feature on the XC3S200 FPGAs shown in [Table 8](#) with a "CGQ" Fabrication/Process Code marking, as shown in [Figure 2](#).
