# **TMS320C6746 Fixed- and Floating-Point DSP Silicon Revisions 2.3, 2.1, 2.0, 1.1 and 1.0**

## **Silicon Errata**

Literature Number: SPRZ304H  
June 2009–Revised March 2014

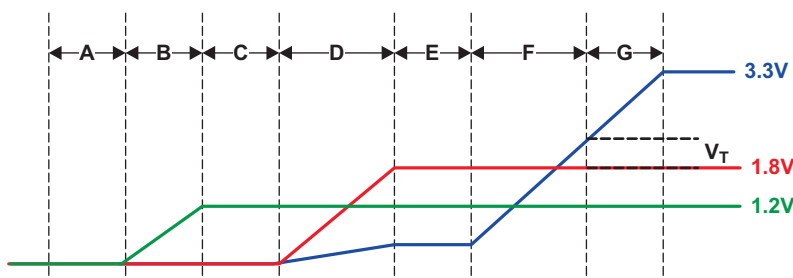
**Figure 5. Normal power-supply ramp**

**Important Note:** The 3.3V DVDD3318\_x supplies must not be driven to 0V during zones A – E or high current capable of damaging the device may occur. The 3.3V DVDD3318\_x supplies should not be driven during this time.

- A. All device supplies are undriven
- B. The 1.2V supplies are ramped to their nominal levels
- C. Potential delay between supply ramps (not required)
- D. The 1.8V supplies (specifically DVDD18) are ramped to their nominal levels. During the DVDD18 ramp there will be some minor drift up in the undriven DVDD3318\_x supplies. This is normal and is not a problem.
- E. Potential delay between supply ramps (not required)
- F. DVDD3318\_x is ramping but is less than DVDD18 +  $V_T$
- G. DVDD3318\_x is ramping but is greater than DVDD18 +  $V_T$

The behavior is the same until zone G. When the DVDD3318\_x supply exceeds DVDD18 by a transistor  $V_T$ , the DVDD18 supply begins to be pulled up by the DVDD3318\_x supply and follows the DVDD3318\_x supply by DVDD3318\_x -  $V_T$ . Since the DVDD18 supply is often connected to other 1.8V supplies in the design, these other supplies can be pulled up also.
