# **AM3517, AM3505 Sitara™ Processors**

## **Silicon Revisions 1.1, 1.0**

# **Silicon Errata**

Literature Number: SPRZ306E  
October 2009–Revised September 2016

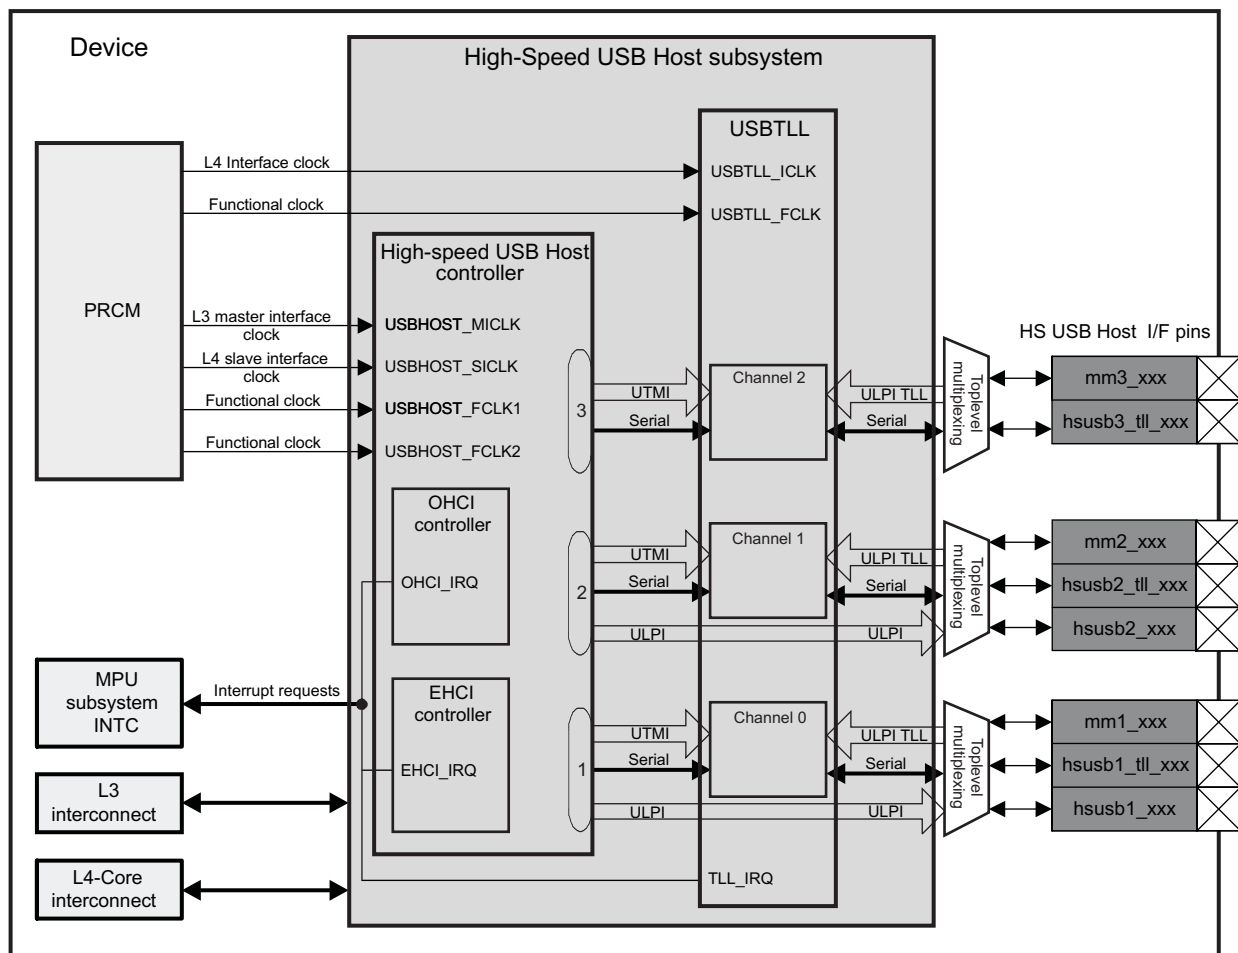
**Figure 3. High-Speed USB Host Subsystem Highlight**

Please note the following functional limitations when using the high-speed USB host subsystem:

- If one port is configured in the ULPI mode, then all other ports must use the same configuration. Therefore, the ports must be configured high-speed mode or full-speed/low-speed mode. For more information, see [ECHI and OHCI Controllers Cannot Work Concurrently](#).
- USB Port 3 cannot operate in ULPI mode; it can only operate in serial mode.
