**TMS320VC5421**  
**Digital Signal Processor**  
**Silicon Errata**

*SPRZ170C*  
April 2000  
Revised October 2001

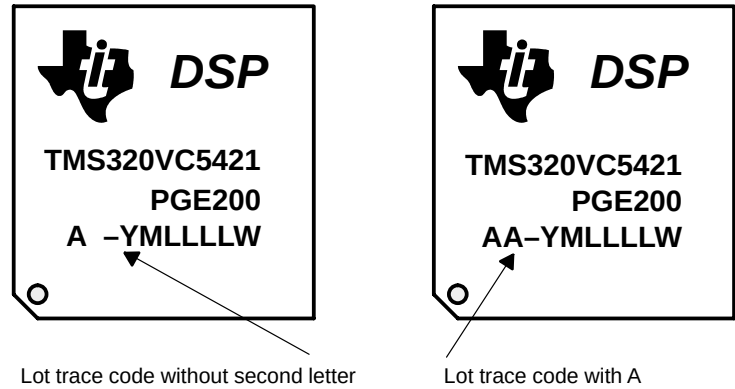
Figure 1. Example, Typical Lot Trace Code for TMS320VC5421 (PGE)

The device revision can be determined by the lot trace code marked on the top of the package. The locations for the lot trace codes for the PGE and the GGU packages are shown in Figure 1 and Figure 2, respectively. The location of other markings may vary per device.

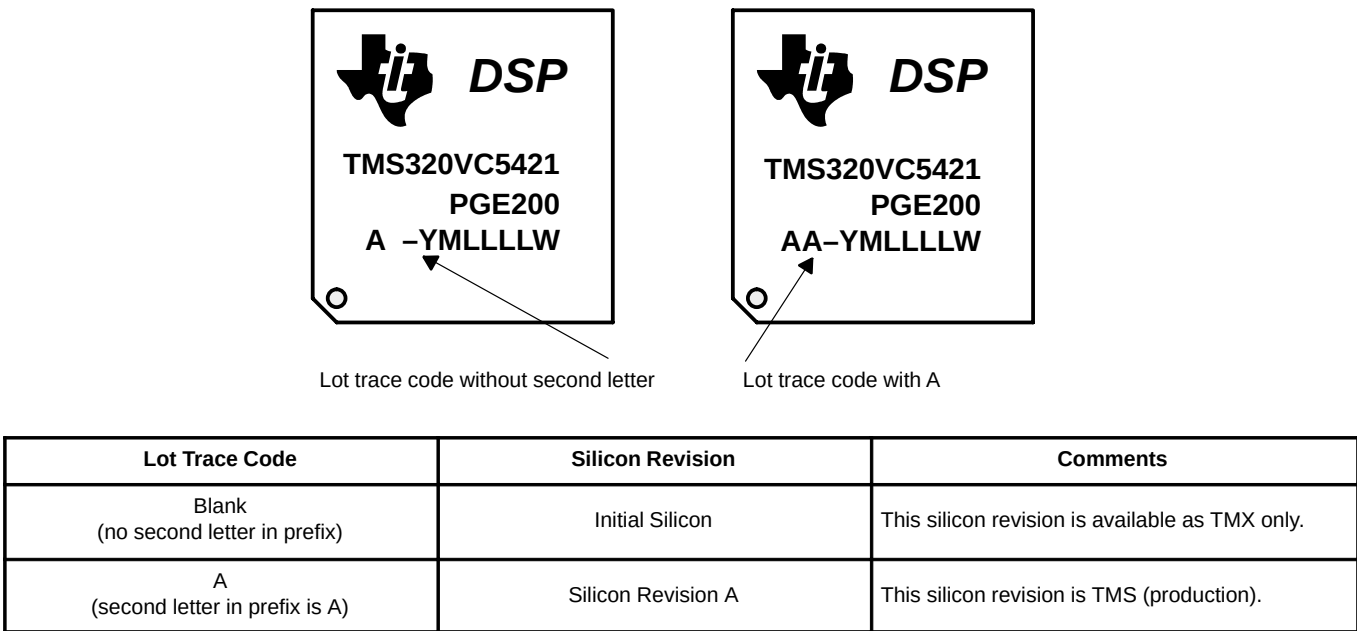
Figure 1. Example, Typical Lot Trace Code for TMS320VC5421 (PGE)

The device revision can be determined by the lot trace code marked on the top of the package. The locations for the lot trace codes for the PGE and the GGU packages are shown in Figure 1 and Figure 2, respectively. The location of other markings may vary per device.
