# OMAP-L138 C6000 DSP+ARM® Processor Silicon Revisions 2.3, 2.1, 2.0, 1.1 and 1.0

## Silicon Errata

Literature Number: SPRZ301M  
June 2009–Revised March 2014

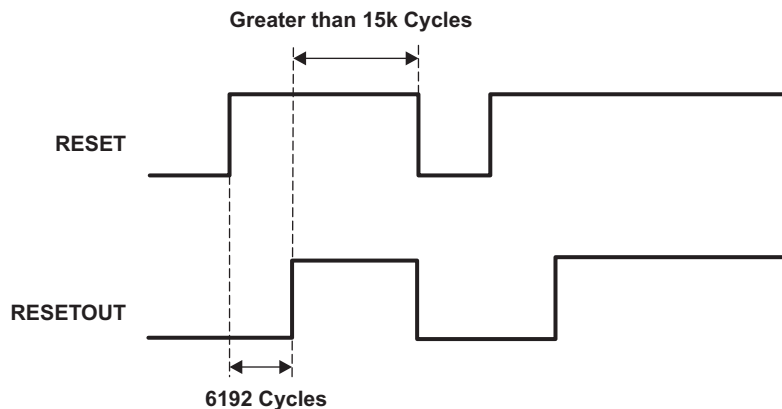
**Figure 16. First POR Reset Timing**

Note that in order to recover from this fail state with a secondary reset, the DSP must be allowed to execute its boot ROM up to the point where the PRU has fetched a known instruction from the PRU IRAM. The approximate count of 15k cycles into the boot ROM is sufficient.

The 15k clock cycle count does not include the 6192 clock cycles required to complete a device POR reset (see [Figure 16](#)). With a 24MHz crystal, the first RESET signal must be asserted high for at least 883us (or approximately 1ms).

Modify the target board so that the affected device is given a secondary reset on power-up as shown in [Figure 16](#). Two example methods are described in the sections that follow.
