*OMAP3530/25/15/03 Applications Processor*  
**Silicon Revisions 3.1.2, 3.1, 3.0, 2.1, and 2.0**

# Silicon Errata

Literature Number: SPRZ278F  
February 2008—Revised October 2010

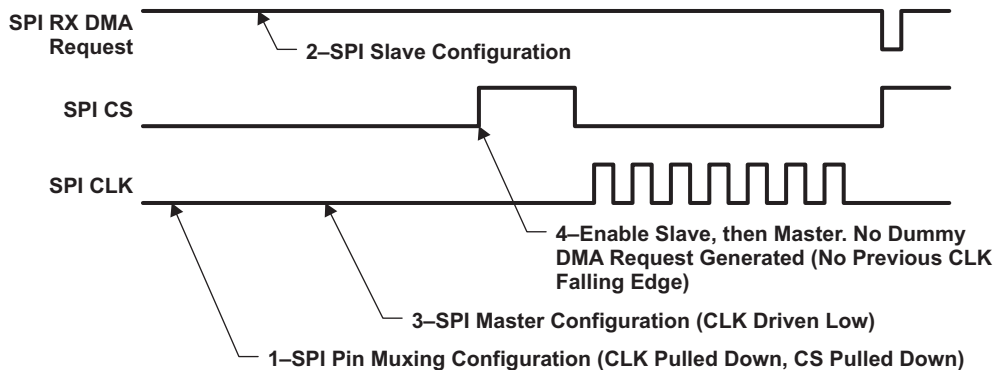
**Figure 6. Dummy DMA RX Generation (No Clock Edge)**

**Workaround(s)** Avoid conditions where the SPI is in *slave* mode and the SPI clock toggles (see examples below).

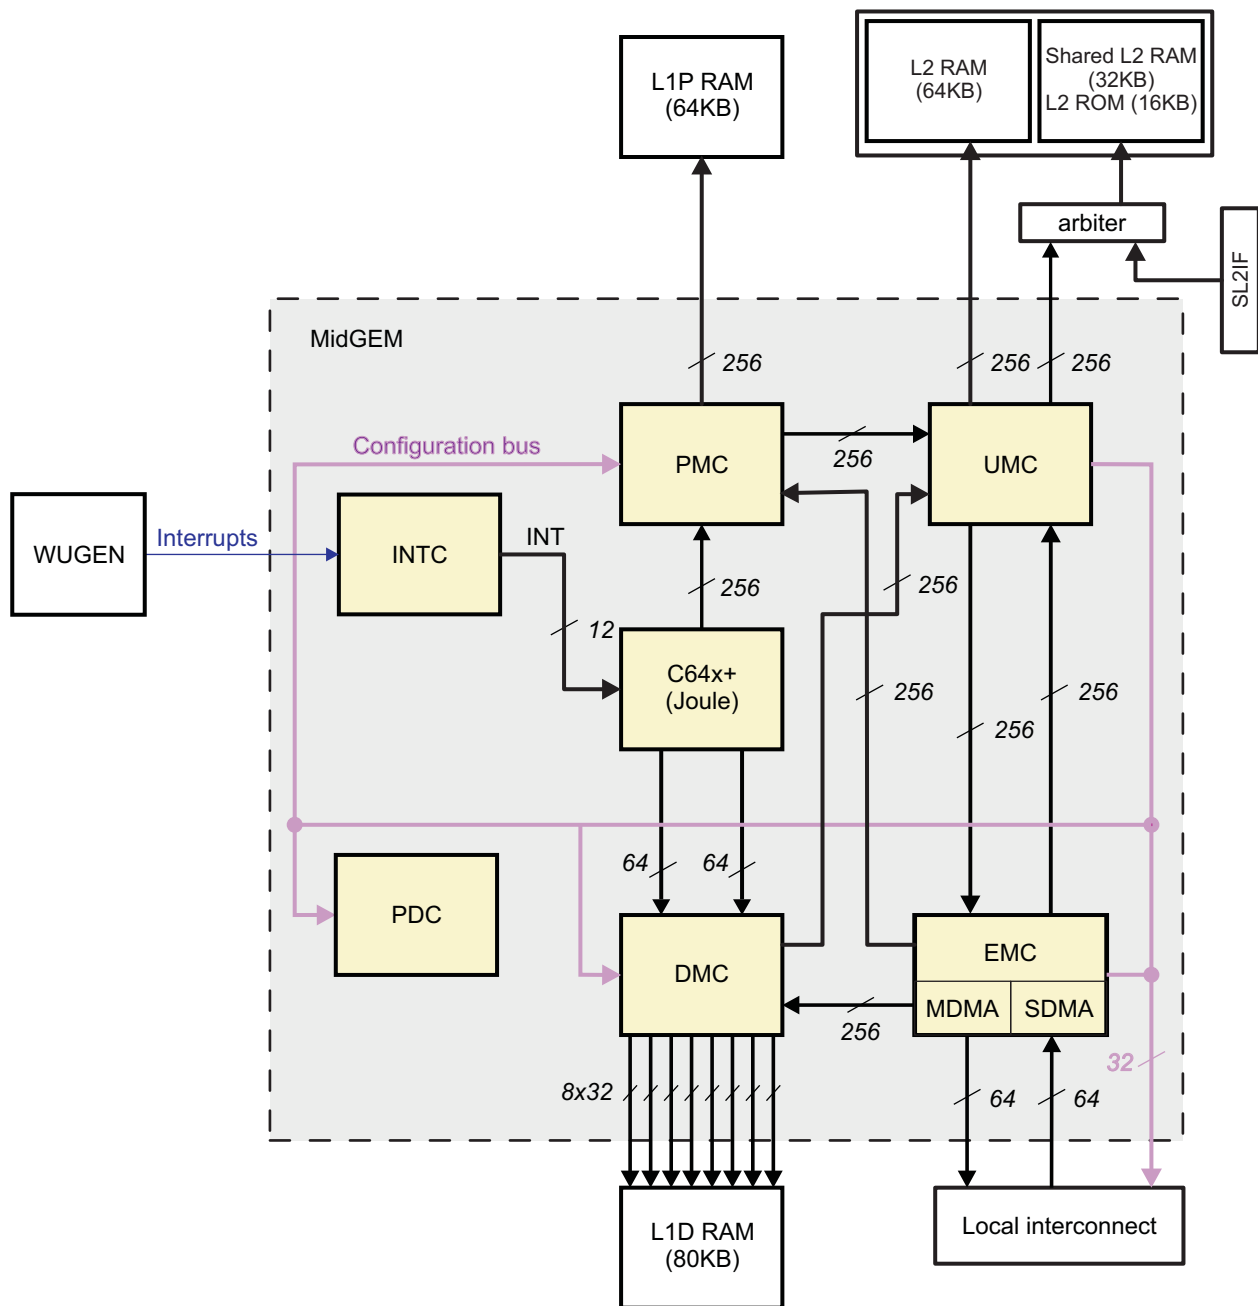
Figure 8. C64x+ Megamodule Block Diagram

Ideally the MDMA and SDMA/IDMA paths operate independently with minimal interference. Normally MDMA accesses may stall for extended periods of time (clock cycles) due to expected system level delays (e.g. due to bandwidth limitations and/or DDR memory refreshes). However, due to the exception, there are cases where SDMA and/or IDMA accesses to L2/L1 experience an additional/unexpected stall during the normal stalls seen by the MDMA interface. For latency sensitive traffic, the SDMA stall can result in missing real time deadlines.

**NOTE:** SDMA/IDMA accesses to L1P/D will not see any unexpected stall if there are no SDMA/IDMA accesses to L2 (both cache/SRAM and shared SRAM). This is because unexpected SDMA/IDMA stalls to L1 happen only when they are pipelined behind L2 accesses which experience stalls due to the exception.

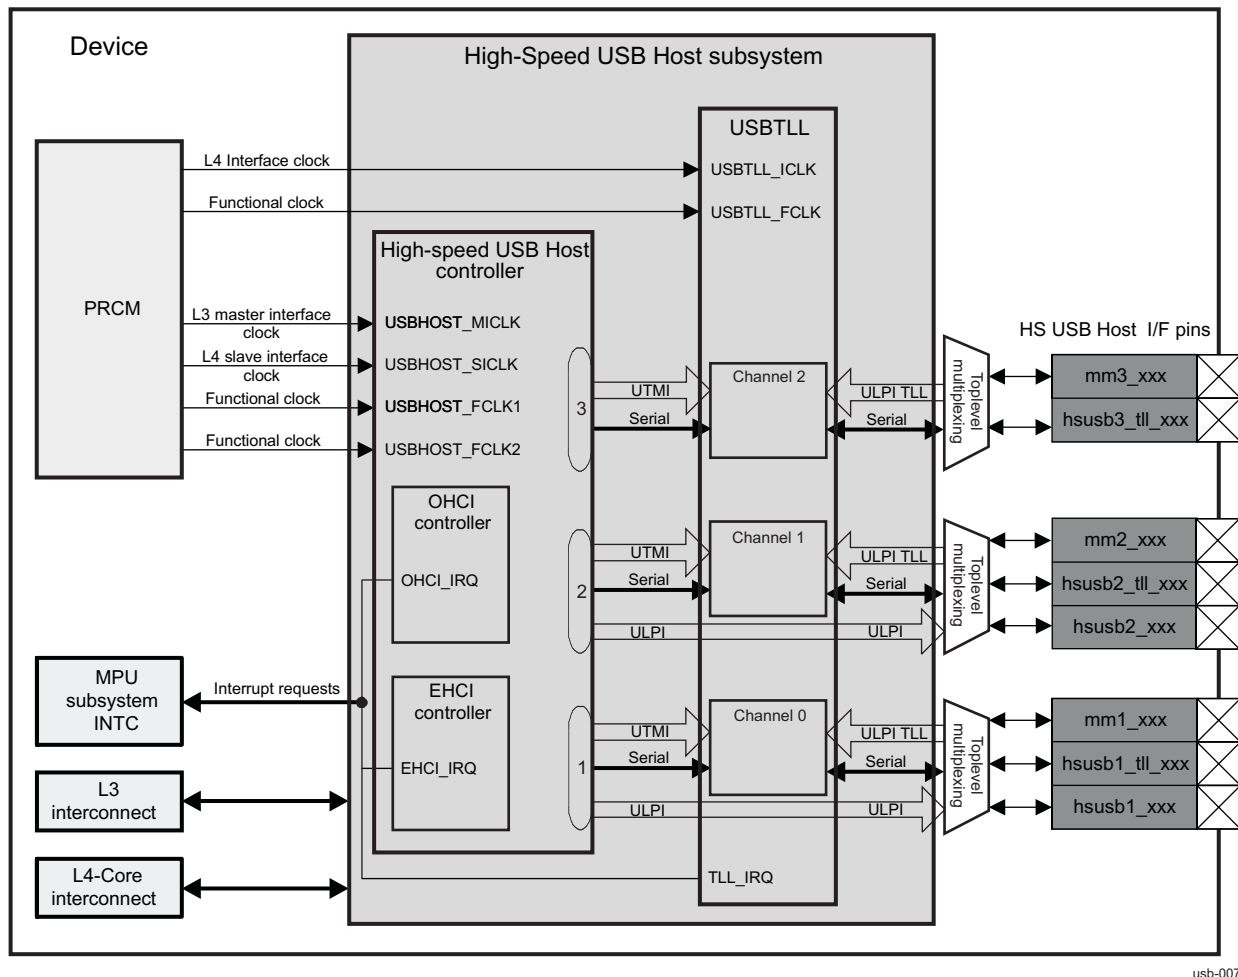
**Figure 13. High-Speed USB Host Subsystem Highlight**

Please note the following functional limitations when using the high-speed USB host subsystem:

- On silicon revision 3.0 and earlier, if one port is configured in the ULPI mode, then all other ports must use the same configuration. Therefore, the ports must be configured high-speed mode or full-speed/low-speed mode.
- USB Port 3 cannot operate in ULPI mode; it can only operate in serial or ULPI TLL mode. Furthermore, USB Port 3 is not available in the CUS package.

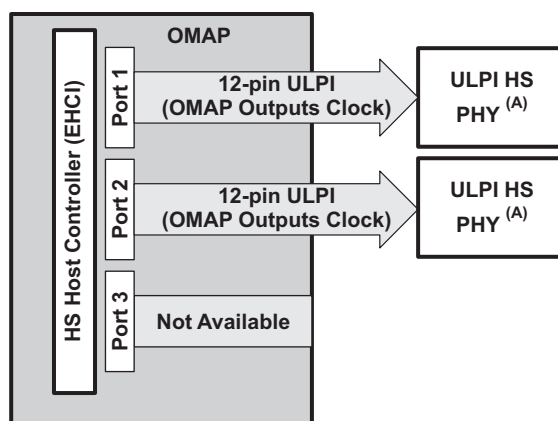
**Figure 14. Connecting to High-Speed PHYs Using USB Ports**

As shown in [Figure 14](#), USB Port 1 and Port 2 can be used to connect to external high-speed PHYs which include a ULPI port. However, in this case, the external USB PHY must be able to accept a source clock generated by the OMAP high-speed USB controller. Also, in this usage model the USB ports cannot support full-speed and low-speed operation. Therefore, using this approach, USB Port 1 and Port 2 cannot provide a fully compliant USB 2.0 Type-A receptacle; a high-speed USB hub would be required in this case; please see [Figure 15](#).

A. USB port 3 does not support ULPI mode.  
Also, USB port 3 not available on CUS package.

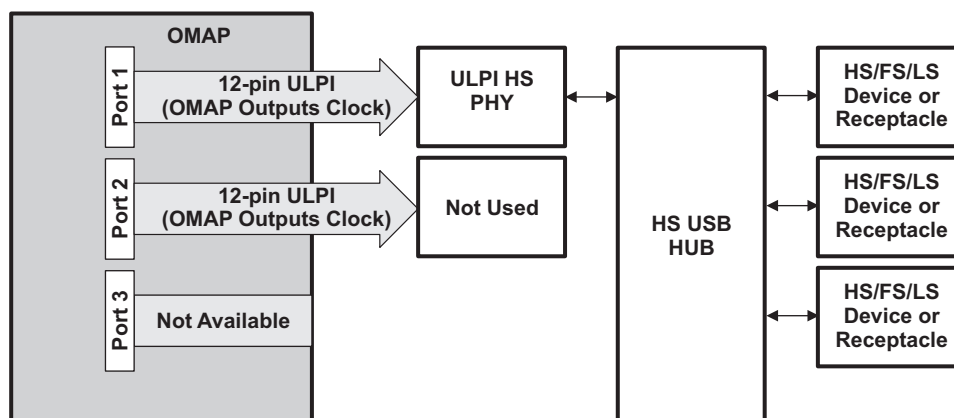
**Figure 15. Connecting to a High-Speed USB Hub**

A. USB port 3 does not support ULPI mode. Also, USB port 3 not available on CUS package.
