# **AM1810 ARM Microprocessor Silicon Revisions 2.3, 2.1 and 2.0**

## **Silicon Errata**

Literature Number: SPRZ339H  
November 2010–Revised September 2014

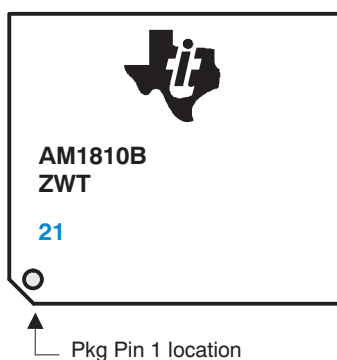
**Figure 1. Device Markings**

| DEVICE REVISION CODE (xx) | SILICON REVISION | COMMENTS |
|---|---|---|
| B | 2.1 | Silicon Revision 2.1 can be differentiated from Revision 2.0 by a top side '21' marking on the package. See <a href="#">Figure 1</a> for details.<br>Additionally the ROM ID code of may be used to distinguish Revision 2.1 from Revision 2.0 |

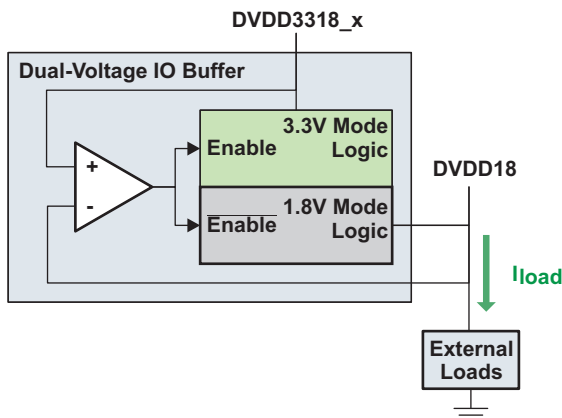
Figure 6. Error State of the IO buffer during Zone G

If DVDD18 continues to rise as DVDD3318\_x ramps, the comparator never sees enough difference between the two supplies to switch to 3.3V mode.

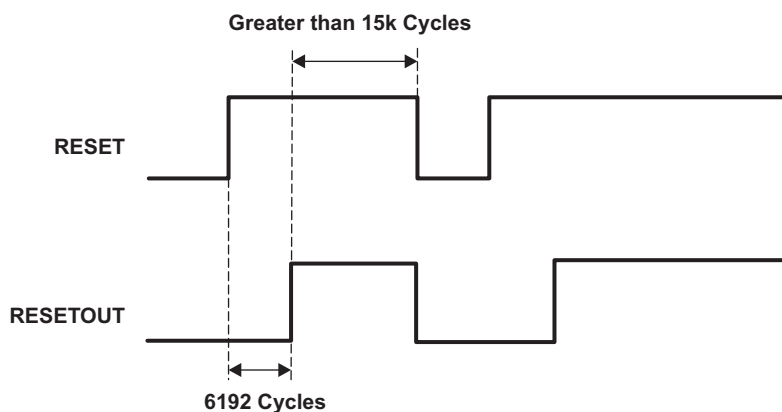
Figure 11. First POR Reset Timing

Note that in order to recover from this fail state with a secondary reset, the Boot Controller must be allowed to execute up to the point where the PRU has fetched a known instruction from the PRU IRAM. The approximate count of 15k clock cycles is sufficient.

The 15k clock cycle count does not include the 6192 clock cycles required to complete a device POR reset (see [Figure 11](#)). With a 24MHz crystal, the first RESET signal must be asserted high for at least 883us (or approximately 1ms).

Modify the target board so that the affected device is given a secondary reset on power-up as shown in [Figure 11](#). Two example methods are described in the sections that follow.
