**TMS320C6678**  
**Multicore Fixed and Floating-Point Digital**  
**Signal Processor**  
**Silicon Revision 1.0, 2.0**

# **Silicon Errata**

Literature Number: SPRZ334H  
January 2011–Revised June 2015

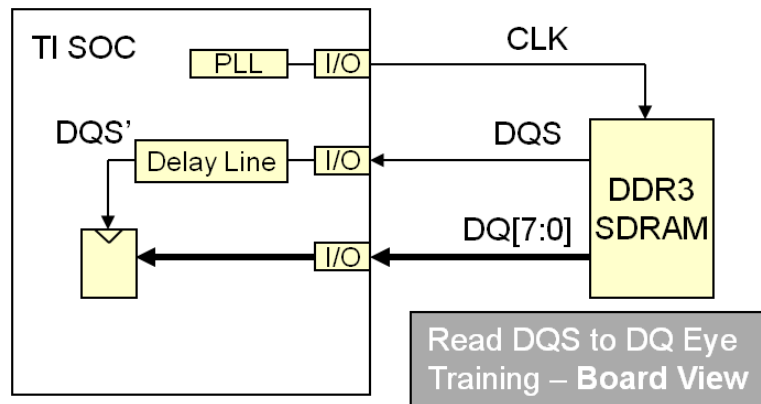
**Figure 2. Read DQS to DQ Eye Training - Board View**

The leveling feature with the problem is the Read Data Eye Training. Depending on the jitter seen on the DQ and DQS signals, this leveling feature will fail to converge on a good data eye, resulting in corrupted DSP to DDR3 SDRAM reads.

The intended purpose of the Read Data Eye Training feature is to align the DQS sampling transitions in the middle of the DQ data eye within individual byte lanes of the DDR3 memory interface. As seen in [Figure 2](#), the DQS signal can be delayed relative to the DQ signal within the DDR3 PHY.

This mode is enabled by setting bit 9 (0-indexed) of the DDR3\_CONFIG\_REG\_23 at address 0x02620460. The lower 8 bits (bits 7:0) must not be overwritten and will contain their default value of 0x34. The default value is recommended for use. After programming DDR3\_CONFIG\_REG\_23, proceed to enable auto-leveling. Please refer to the *DDR3 Initialization Application Report* ([SPRABL2](#)) for details of the sequence of steps.

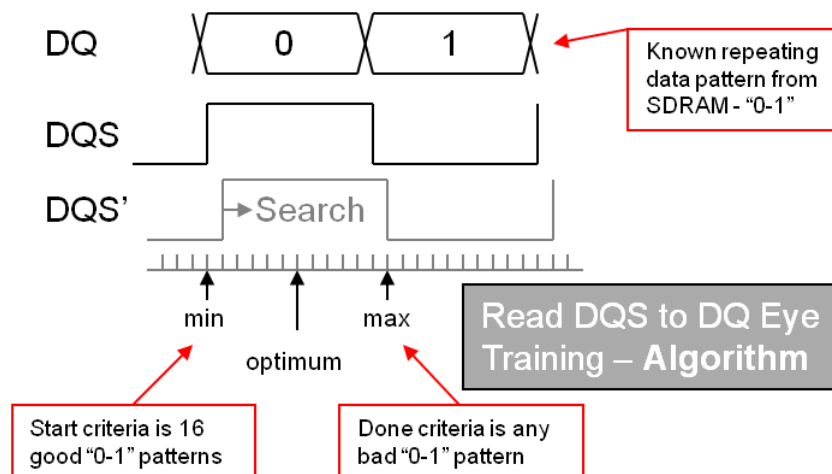
**Figure 3. Read DQS to DQ Eye Training - Algorithm**

As shown in [Figure 3](#), the Read Data Eye Training algorithm should correctly detect the extents of the DQ data eye. The SDRAM are put into a DQS to DQ eye training mode and read back an alternating 0, 1 pattern.

The DDR3 PHY uses this pattern to detect good or bad data being sampled by the DQS transitions. The DDR3 PHY searches by delaying DQS relative to DQ until these constraints are found.

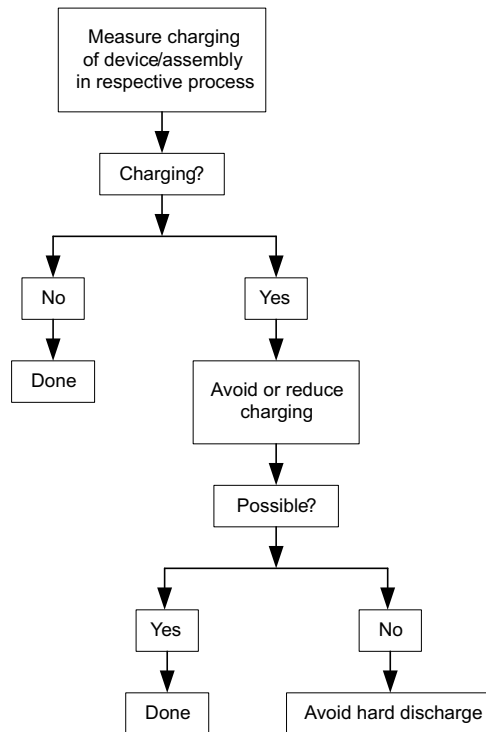
**Figure 6. The Basic Flow to Analyzing the Risk**

- Serial HyperLink Transmit Data Pins
  - MCMTXN0
  - MCMTXP0
  - MCMTXN1
  - MCMTXP1
  - MCMTXN2
  - MCMTXP2
  - MCMTXN3
  - MCMTXP3
- PCI Express Transmit Data Pins
  - PCIETXN0
  - PCIETXP0
  - PCIETXN1
  - PCIETXP1
- Serial RapidIO Transmit Data Pins
  - RIOTXN0
  - RIOTXP0
  - RIOTXN1
  - RIOTXN1
  - RIOTXP1
  - RIOTXN2
  - RIOTXP2
  - RIOTXN3
  - RIOTXP3
- Ethernet MAC SGMII Transmit Data Pins
  - SGMII0TXN
  - SGMII0TXP
  - SGMII1TXN
  - SGMII1TXP

**Workaround:**                      While there is no strict workaround for this issue, there are several ways to analyze the risk with regards to CDM. [Figure 6](#) shows the basic flow for analyzing this risk:

Using generally accepted *good practices* during the assembly process can help to minimize the likelihood of a hard discharge. These practices include:
