**TMS320C6672**  
**Multicore Fixed and Floating-Point Digital**  
**Signal Processor**  
**Silicon Revision 1.0, 2.0**

**Silicon Errata**

Literature Number: SPRZ335H  
January 2011–Revised June 2015

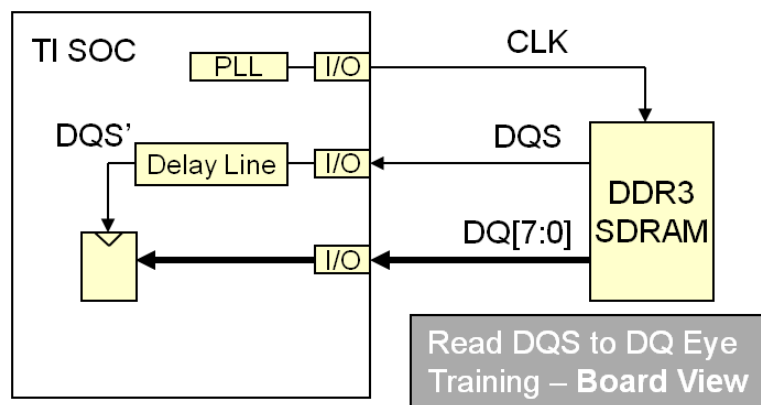
**Figure 2. Read DQS to DQ Eye Training - Board View**

The leveling feature with the problem is the Read Data Eye Training. Depending on the jitter seen on the DQ and DQS signals, this leveling feature will fail to converge on a good data eye, resulting in corrupted DSP to DDR3 SDRAM reads.

The intended purpose of the Read Data Eye Training feature is to align the DQS sampling transitions in the middle of the DQ data eye within individual byte lanes of the DDR3 memory interface. As seen in [Figure 2](#), the DQS signal can be delayed relative to the DQ signal within the DDR3 PHY.

This mode is enabled by setting bit 9 (0-indexed) of the DDR3\_CONFIG\_REG\_23 at address 0x02620460. The lower 8 bits (bits 7:0) must not be overwritten and will contain their default value of 0x34. The default value is recommended for use. After programming DDR3\_CONFIG\_REG\_23, proceed to enable auto-leveling. Please refer to the *DDR3 Initialization Application Report* ([SPRABL2](#)) for details of the sequence of steps.

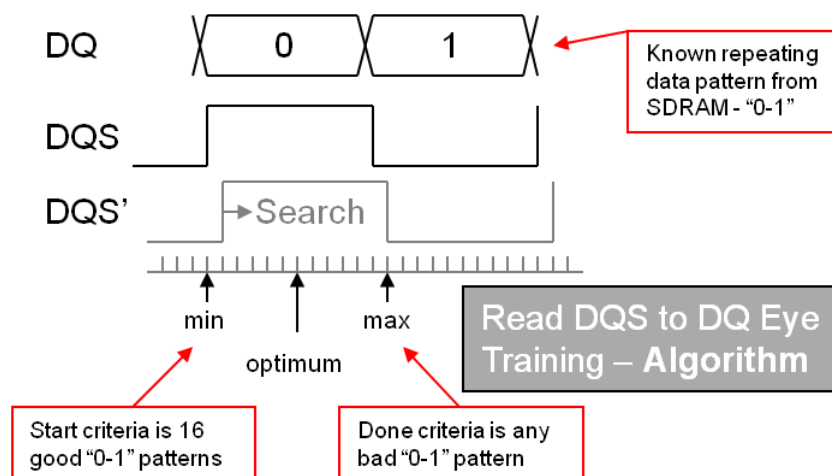
**Figure 3. Read DQS to DQ Eye Training - Algorithm**

As shown in [Figure 3](#), the Read Data Eye Training algorithm should correctly detect the extents of the DQ data eye. The SDRAM are put into a DQS to DQ eye training mode and read back an alternating 0, 1 pattern.

The DDR3 PHY uses this pattern to detect good or bad data being sampled by the DQS transitions. The DDR3 PHY searches by delaying DQS relative to DQ until these constraints are found.

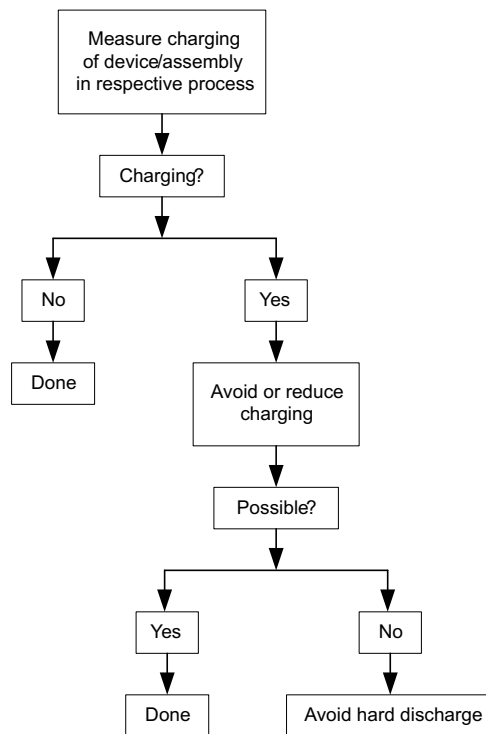
**Figure 6. The Basic Flow to Analyzing the Risk**

- Serial HyperLink Transmit Data Pins
  - MCMTXN0
  - MCMTXP0
  - MCMTXN1
  - MCMTXP1
  - MCMTXN2
  - MCMTXP2
  - MCMTXN3
  - MCMTXP3
- PCI Express Transmit Data Pins
  - PCIETXN0
  - PCIETXP0
  - PCIETXN1
  - PCIETXP1
- Serial RapidIO Transmit Data Pins
  - RIOTXN0
  - RIOTXP0
  - RIOTXN1
  - RIOTXN1
  - RIOTXP1
  - RIOTXN2
  - RIOTXP2
  - RIOTXN3
  - RIOTXP3
- Ethernet MAC SGMII Transmit Data Pins
  - SGMII0TXN
  - SGMII0TXP
  - SGMII1TXN
  - SGMII1TXP

**Workaround:**                      While there is no strict workaround for this issue, there are several ways to analyze the risk with regards to CDM. [Figure 6](#) shows the basic flow for analyzing this risk:

Using generally accepted *good practices* during the assembly process can help to minimize the likelihood of a hard discharge. These practices include:
