# **AM1808 ARM Microprocessor Silicon Revisions 2.3, 2.1, 2.0, and 1.1**

## **Silicon Errata**

Literature Number: SPRZ313H  
March 2010–Revised September 2014

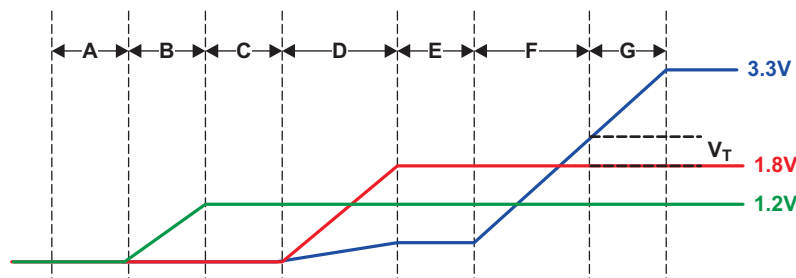
**Figure 3. Normal power-supply ramp**

- A. All device supplies are undriven
- B. The 1.2V supplies are ramped to their nominal levels
- C. Potential delay between supply ramps (not required)
- D. The 1.8V supplies (specifically DVDD18) are ramped to their nominal levels. During the DVDD18 ramp there will be some minor drift up in the undriven DVDD3318\_x supplies. This is normal and is not a problem.
- E. Potential delay between supply ramps (not required)
- F. DVDD3318\_x is ramping but is less than DVDD18 +  $V_T$
- G. DVDD3318\_x is ramping but is greater than DVDD18 +  $V_T$

**Important Note:** The 3.3V DVDD3318\_x supplies must not be driven to 0V during zones A – E or high current capable of damaging the device may occur. The 3.3V DVDD3318\_x supplies should not be driven during this time.

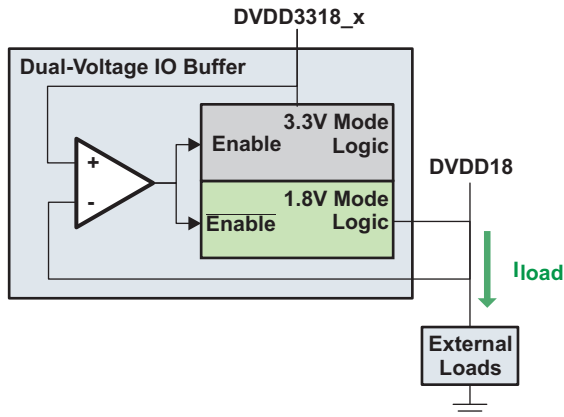
The condition occurs because the dual-voltage IO buffers have voltage detection circuitry that monitors DVDD3318\_x during reset and determines whether the applied supply voltage is 1.8V or 3.3V. This detection circuitry then configures the IOs to operate at the appropriate voltage. As the DVDD3318\_x supply ramps, there is a small range near DVDD18 +  $V_T$  where the voltage detection circuit finds the state indeterminate and briefly turns on circuitry associated with both voltage options creating a current path between them. This current path can cause the DVDD18 supply to be pulled up. The mechanism for this behavior is explained below:

**Behavior of the IO buffer during Zone F:**

As the DVDD3318\_x supply ramps, but is not yet one  $V_T$  above the DVDD18 supply, the comparator enables the 1.8V mode logic section and disables the 3.3V mode logic section. No unexpected current flows between the two sections.

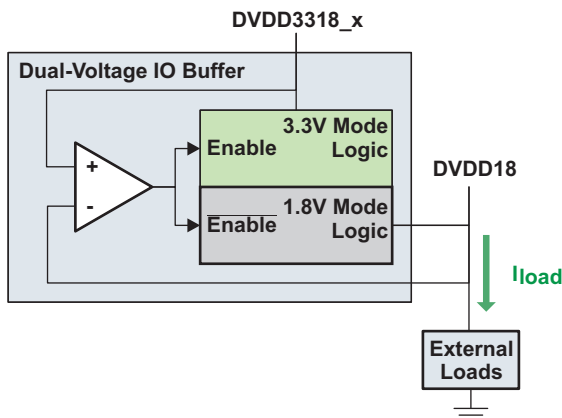
**Recovered State of the IO buffer during Zone G:**

If the load current is high enough or the DVDD18 power supply can oppose the leakage current, then the DVDD18 voltage stays low enough for:

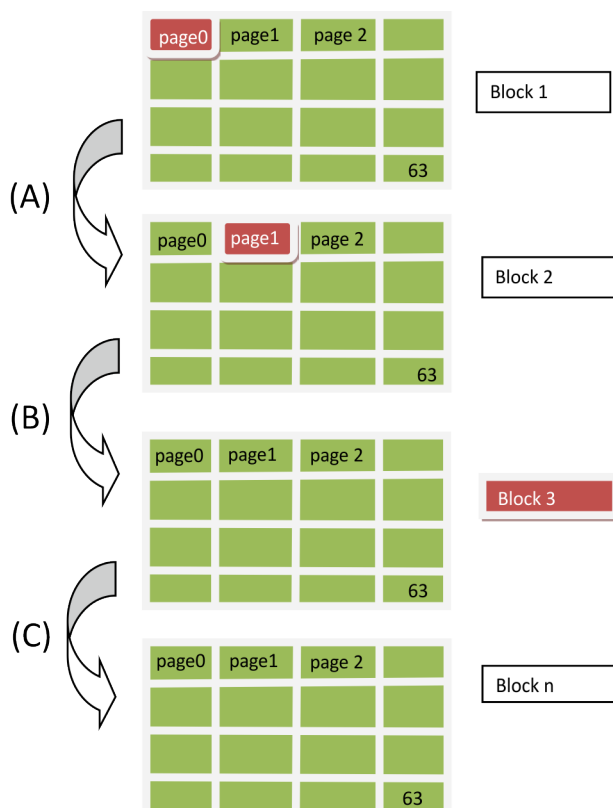
## D800K008 ROM Behavior Before Application of Software Patch<sup>(1)</sup> (continued)

(1) All pages marked in **green** are good and all pages marked in **red** have "uncorrectable" errors.

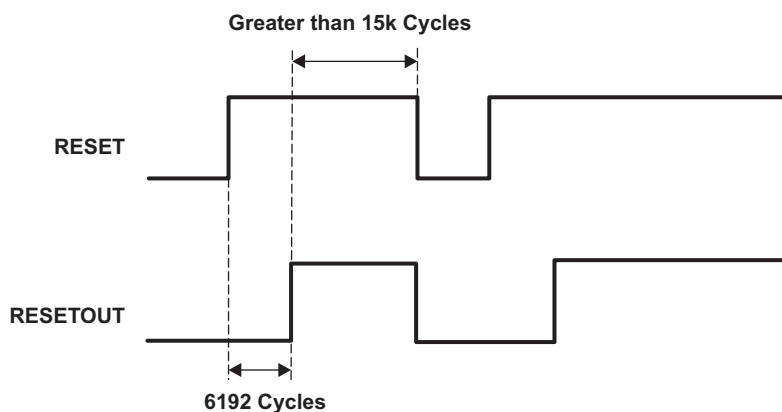
Figure 11. First POR Reset Timing

Note that in order to recover from this fail state with a secondary reset, the Boot Controller must be allowed to execute up to the point where the PRU has fetched a known instruction from the PRU IRAM. The approximate count of 15k clock cycles is sufficient.

The 15k clock cycle count does not include the 6192 clock cycles required to complete a device POR reset (see [Figure 11](#)). With a 24MHz crystal, the first RESET signal must be asserted high for at least 883us (or approximately 1ms).

Modify the target board so that the affected device is given a secondary reset on power-up as shown in [Figure 11](#). Two example methods are described in the sections that follow.

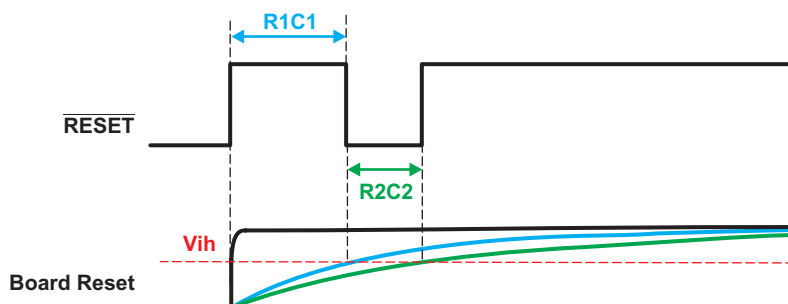
**Figure 14. RESET Signal vs Board Reset**

[Figure 14](#) shows the relationship between the board reset signal and the RESET signal produced by the circuit. The blue and green lines represent the voltage as seen by the Schmitt buffers. The output voltage of a charging RC circuit is defined as:  $V_o = V_i * (1 - e^{-t / RC})$

Given ideal conditions, a 3.3V board reset signal, and an input buffer  $V_{ih}$  of 1.4V, the following set of component values would generate an initial RESET high period (R1C1 region) of approximately 2ms and a RESET low period (R2C2 region) of approximately 0.5ms:
