**66AK2Hxx**  
**Multicore DSP+ARM KeyStone II SOC**  
**Silicon Revisions 1.0, 1.1, 2.0, 3.0, 3.1**

# **Silicon Errata**

Literature Number: SPRZ402F  
June 2013—Revised June 2018

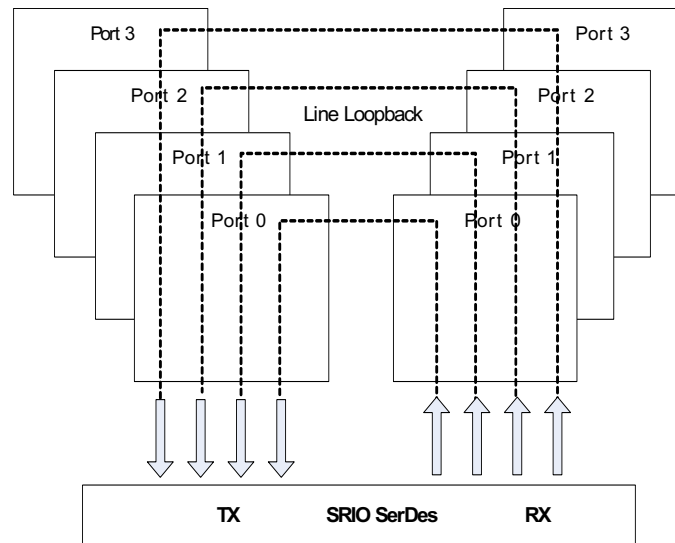
**Figure 2. SRIO SerDes in Loopback Mode**

The SRIO physical layer is configured in line-loopback mode on a per-port basis, by setting the LLB\_EN bit in PLM\_SP(n)\_IMP\_SPEC\_CTL register. In line-loopback mode, the data from the SerDes receiver is looped back to the SerDes transmitter. [Figure 2](#) shows the line loopback from SerDes RX to SerDes TX.

The port does not provide any clock compensation when line loopback is enabled. The transmit clock must be externally synchronized with the receive clock. There is only a small FIFO that can compensate for PLL jitter or wander. Hence, correct operation of line loopback requires that the link partners use the same reference clock for the SRIO physical layer, in order to avoid overruns or underruns due to clock frequency mismatch between the link partners. As a result, line loopback mode is generally restricted to validation and qualification of board signal integrity in a lab environment.
