# **AM1802 ARM Microprocessor Silicon Revisions 2.3, 2.1 and 2.0**

## **Silicon Errata**

Literature Number: SPRZ340H  
November 2010–Revised September 2014

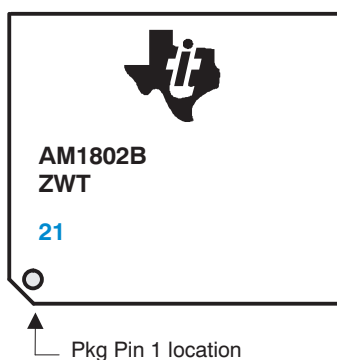
**Figure 1. Device Markings**

| DEVICE REVISION CODE (xx) | SILICON REVISION | COMMENTS |
|---|---|---|
| B | 2.1 | Silicon Revision 2.1 can be differentiated from Revision 2.0 by a top side '21' marking on the package. See <a href="#">Figure 1</a> for details.<br>Additionally the ROM ID code of may be used to distinguish Revision 2.1 from Revision 2.0 |

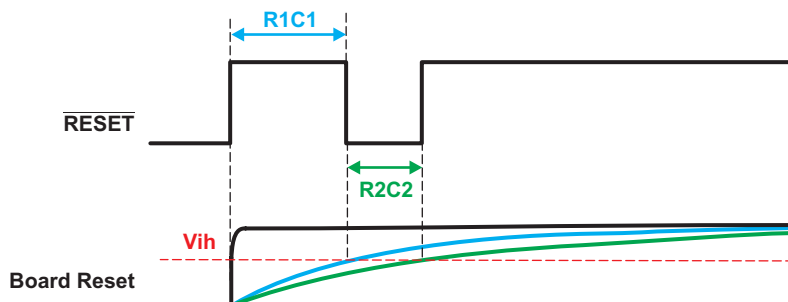
**Figure 11. RESET Signal vs Board Reset**

This is possible because each RC load connected to the board reset control signal can output a different rising-edge waveform. With increasing RC load, the resulting control signal will reach the Schmitt buffers'  $V_{ih}$  level at a later point in time. [Figure 11](#) shows the relationship between the board reset signal and the RESET signal produced by the circuit. The blue and green lines represent the voltage as seen by the Schmitt buffers. The output voltage of a charging RC circuit is defined as:  $V_o = V_i * (1 - e^{-t / RC})$

Given ideal conditions, a 3.3V board reset signal, and an input buffer  $V_{ih}$  of 1.4V, the following set of component values would generate an initial RESET high period (R1C1 region) of approximately 2ms and a RESET low period (R2C2 region) of approximately 0.5ms:

2. Implement a logic-based secondary reset circuit which is timed using RC components. For the circuit shown in [Figure 10](#), a single board reset control signal can trigger three logic transitions in a dual XOR gate device.
