**OMAP-L137  
C6000 DSP+ARM Processor  
Silicon Revisions 3.0, 2.1, 2.0, 1.1, and 1.0**

# **Silicon Errata**

Literature Number: SPRZ291I  
October 2008–Revised June 2014

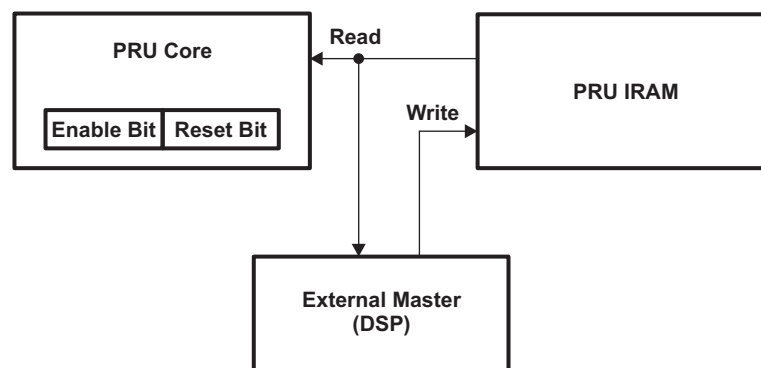
**Figure 4. PRU and DSP Block Diagram**

The ARM reset vector table is located in the ARM's local RAM, however the ARM local RAM can only be accessed by two bus masters: ARM and PRU0. Therefore, the DSP must program PRU0 to copy the desired reset vector table into the ARM's local RAM.

The PRU instructions are located inside of an instruction RAM (IRAM) which is initialized by the DSP during ROM boot (see Figure 4). After the instructions are stored to IRAM, the PRU is reset and enabled to execute its instructions. In this case, the PRU is instructed to initialize the ARM reset vector table.
