# **TMS320C6652/54/55/57**

#### **Silicon Revision 1.0**

## **Silicon Errata**

Literature Number: SPRZ381C  
April 2012–Revised May 2016

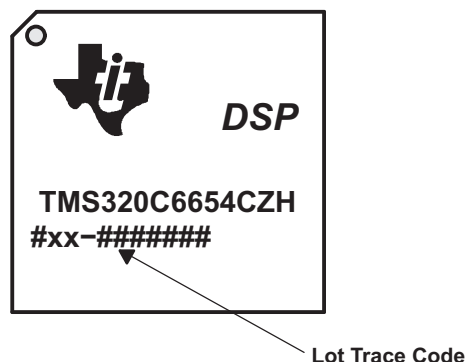
**Figure 1. Lot Trace Code Example for TMS320C6654 (CZH Package)**

The device revision can be determined by the lot trace code marked on the top of the package. The location of the lot trace code for the CZH package is shown in Figure 1. Figure 1 also shows an example of the C6654CZH package symbolization.

Silicon revision correlates to the lot trace code marked on the package. This code is of the format #xx-#####. Note that there may be an additional leading character (not shown in this example) and xx may actually be two or three characters. If xx is **10**, then the silicon is revision 1.0. Table 1 lists the silicon revisions associated with each lot trace code for the C6652/54/55/57 devices.
