**OMAP5912**  
**Applications Processor**  
**Silicon Errata**

SPRZ209K  
December 2003 – Revised December 2007

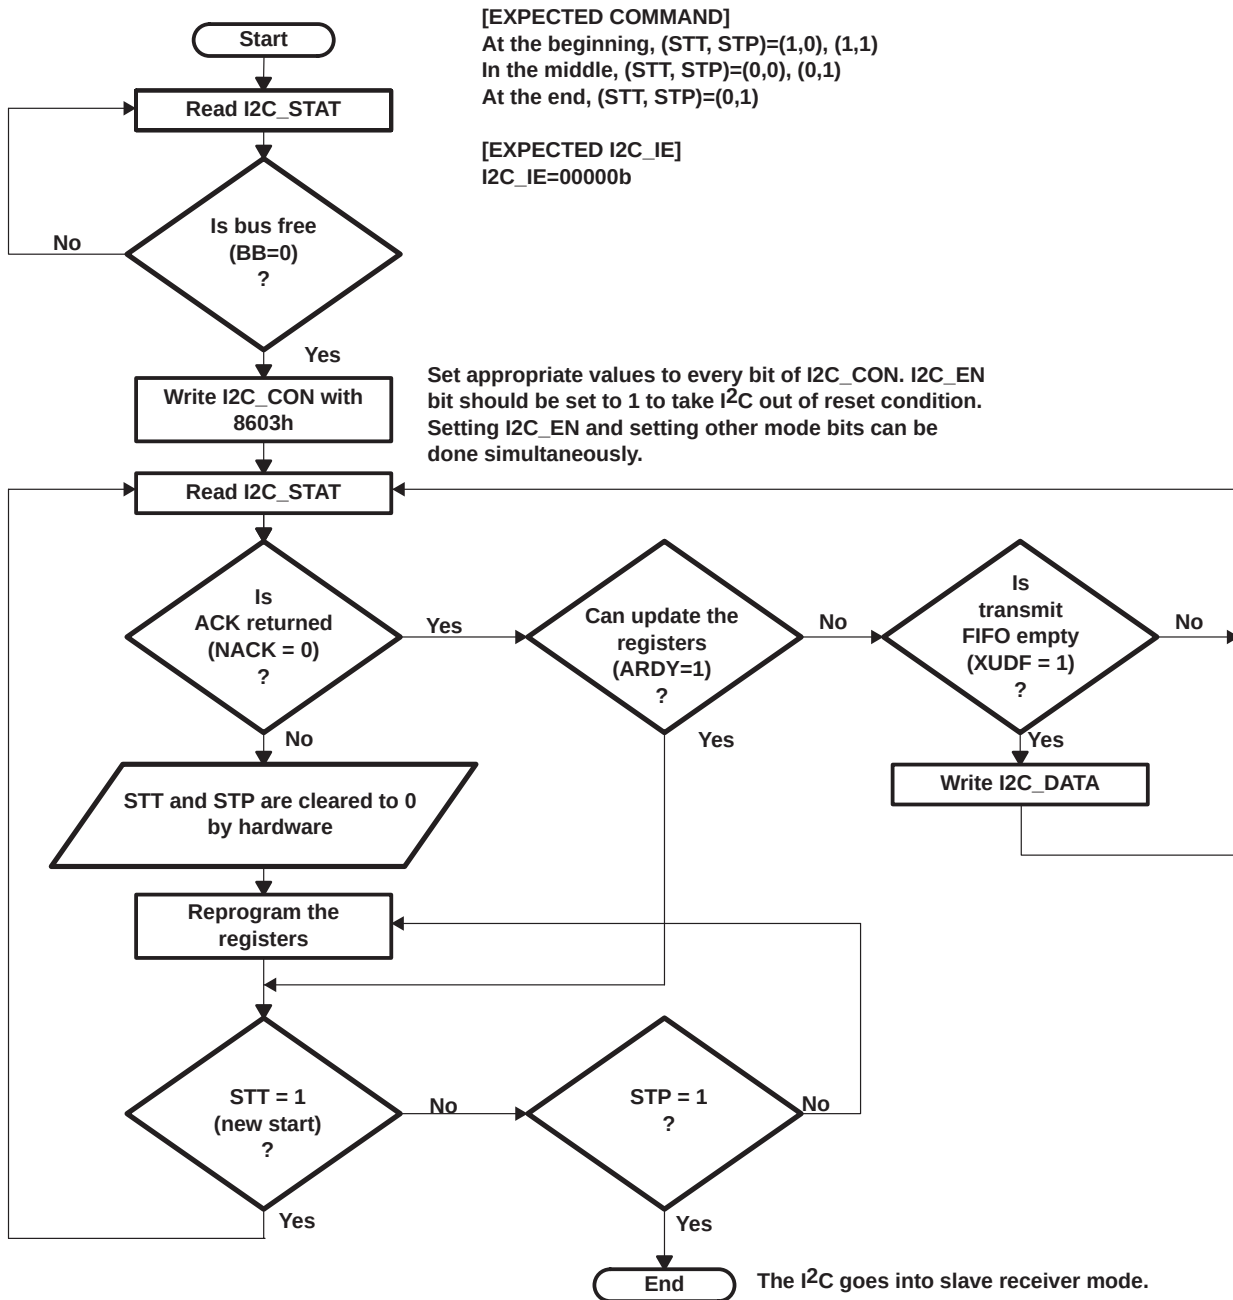
Figure 7. Master Transmitter Mode Polling Flow Diagram

Figure 7 and Figure 8 show the flowcharts of master transmit operation in polling and interrupt modes.

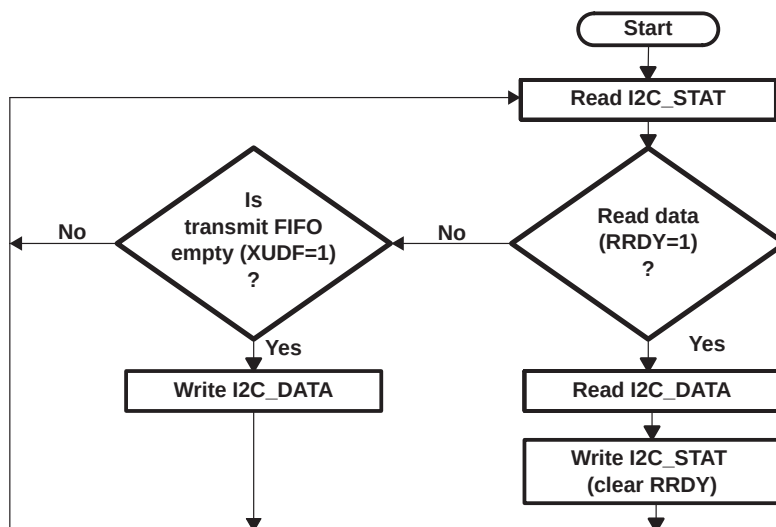
**Figure 9. Slave Transmitter/Receiver Mode Polling Flow Diagram**

Figure 9 and Figure 10 show the flowcharts of slave transmit/receive operation in interrupt and polling modes.

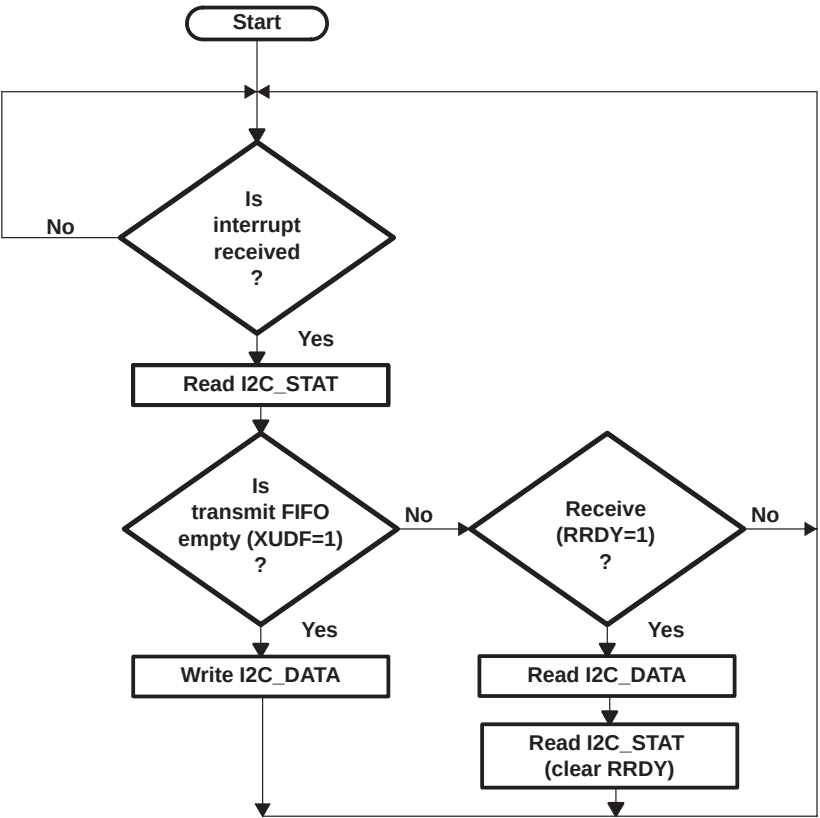
**Figure 10. Slave Transmitter/Receiver Mode Interrupt Flow Diagram**

This exception will not be fixed in future silicon revisions.
