# **TMS320C6455/54**

## **Digital Signal Processor**

### **Silicon Revisions 3.1, 2.1, 2.0, 1.1**

## **Silicon Errata**

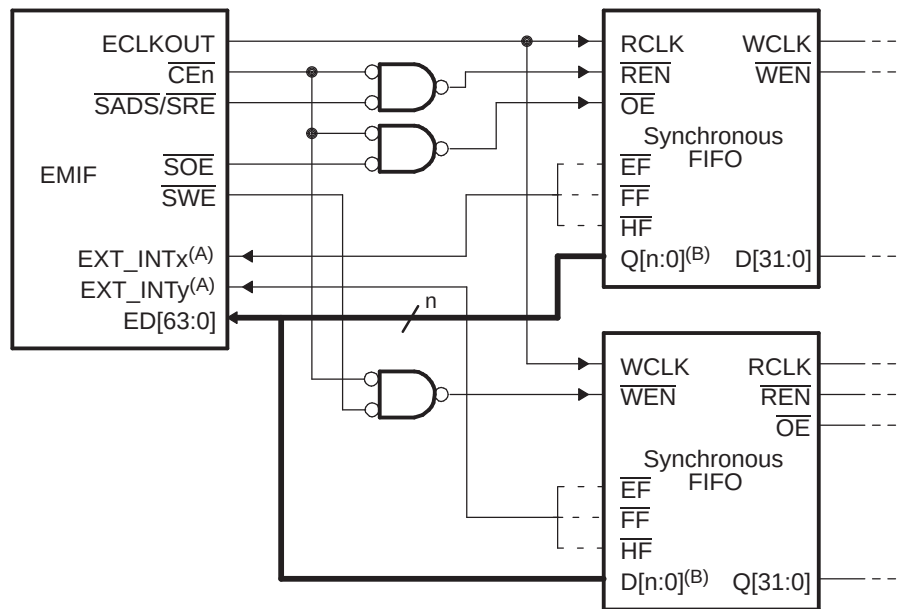
**Figure 2. Read and Write Synchronous FIFO Interface With Glue Block Diagram**

The state of the EMIFA control pins is not defined while the chip enable pins ( $\overline{\text{CE}}[5:2]$ ) are high. Furthermore, some control pins may become active while the chip enable pins are driven high. To avoid erroneously activating devices connected to EMIFA, the chip enable pins should be used to select/deselect these devices. If a device being used does not have a chip enable input, then the control pins going to that device should be qualified with a chip enable pin. An example of this is shown in [Figure 2](#).

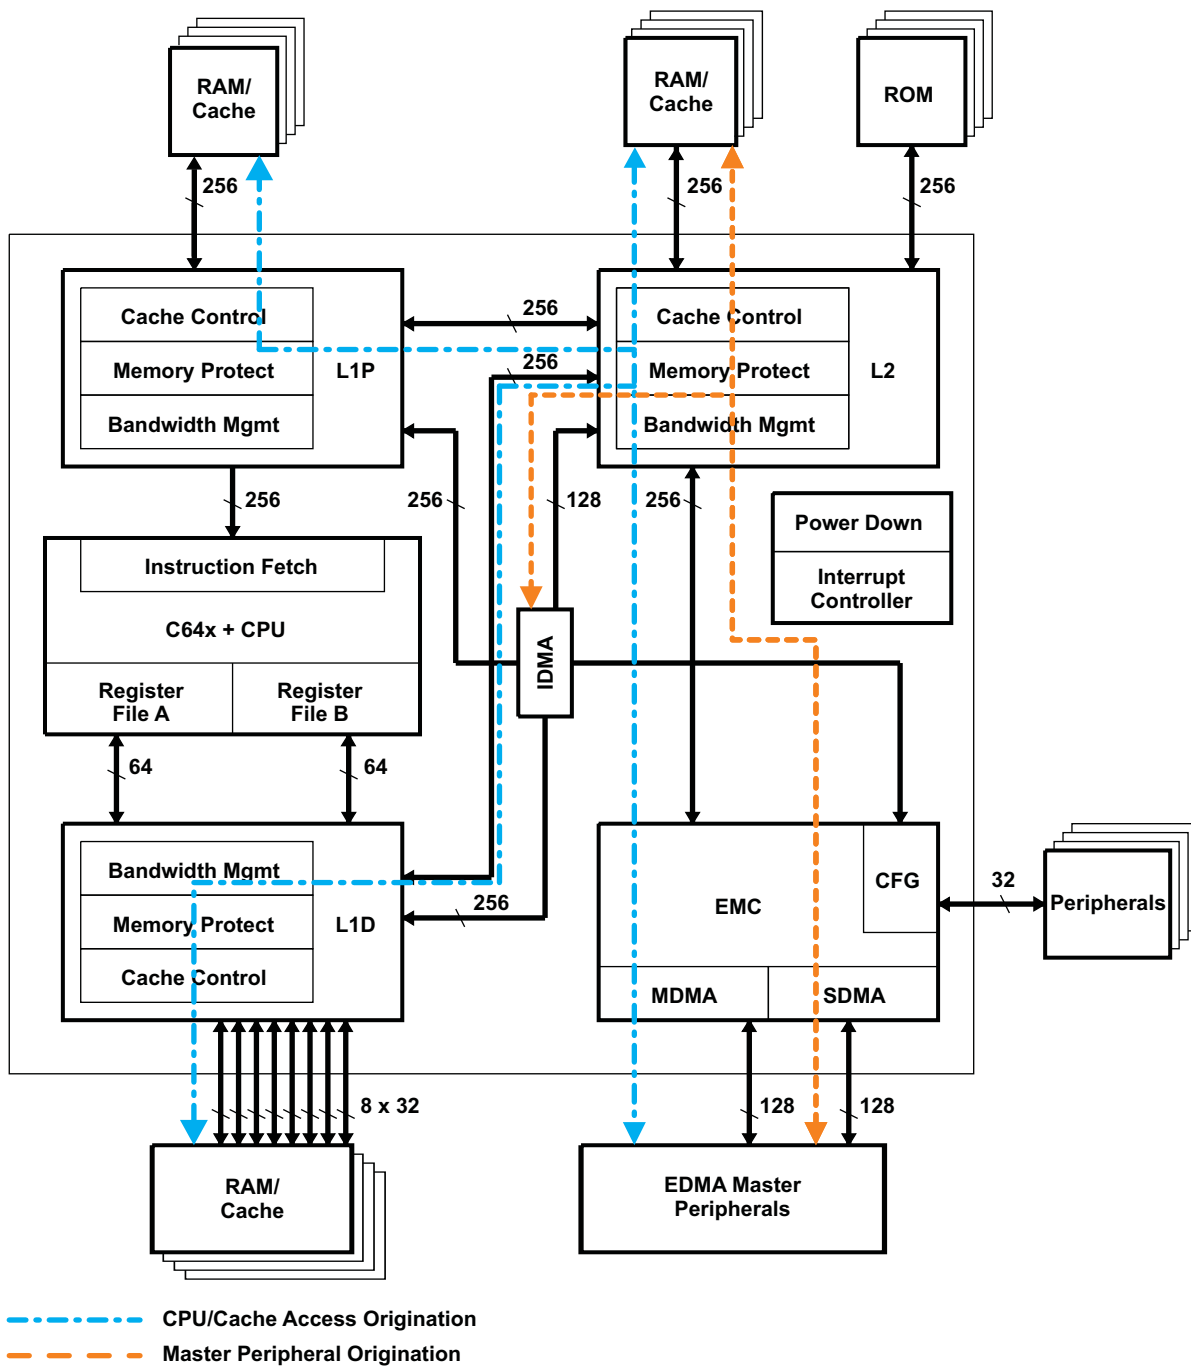
Figure 15. IDMA, SDMA, and MDMA Paths

Ideally, the MDMA (the blue lines in [Figure 15](#)) and SDMA/IDMA paths (the orange lines in [Figure 15](#)) operate independently with minimal interference. Normally, MDMA accesses may stall for extended periods of time (clock cycles) due to expected system level delays (e.g., bandwidth limitations, DDR2 memory refreshes). However, when using L2 as RAM, SDMA and/or IDMA accesses to L2/L1 may experience unexpected stalling in addition to the normal stalls seen by the MDMA interface. For latency-sensitive traffic, the SDMA stall can result in missing real-time deadlines. In a more severe case, the SDMA stall can produce a deadlock condition in the device.

SDMA/IDMA stalls may occur during the following scenarios. Each of these scenarios describes expected normal DSP functionality, but the SDMA/IDMA access potentially exhibits additional unexpected stalling.

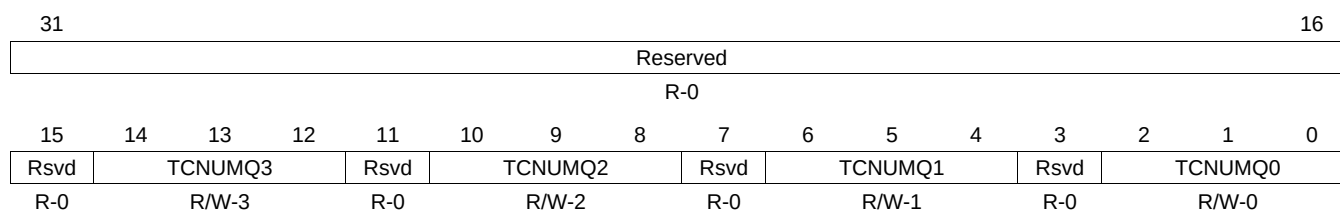
**Figure 16. QUETCMAP Register (02A0 0280h)**

For example, abiding by the default settings, McBSP events need to be submitted on Q1 since TC1 is the only TC with connectivity to this peripheral. McBSP transfers might be at risk if there are events pending on Q0. In order to reduce this risk, the default mapping of Q0 can be changed such that it maps to TC1. In this manner, an event on Q0 results in a TR submission to TC1 thus minimizing the risk of a real-time miss due to this issue.

2. By default, each queue maps directly to a corresponding transfer controller (TC); i.e., Q0 maps to TC0, Q1 maps to TC1, etc. If there is a real-time requirement for servicing a peripheral which cannot be accessed via TC0, then Q0 can be mapped to the TC through which the peripheral can be accessed. Queue to TC mapping can be changed via software through the QUETCMAP register (see [Figure 16](#) and [Table 19](#)) as long as only one queue maps to one TC.

Opting for this workaround has other implications on the system. For example, if Q0 is mapped to TC1 then another queue must be mapped to TC0. If Q1 is mapped to TC0, the VCP2 and TCP2 events must be submitted on Q1. Whether this is acceptable would need to be determined by the user.
