PIC18C658/858

PIC18C658/858 Rev. C3 Silicon/Data Sheet Errata

The PIC18C658/858 parts you have received conform functionally to the Device Data Sheet (DS30475**A**), except for the anomalies described below.

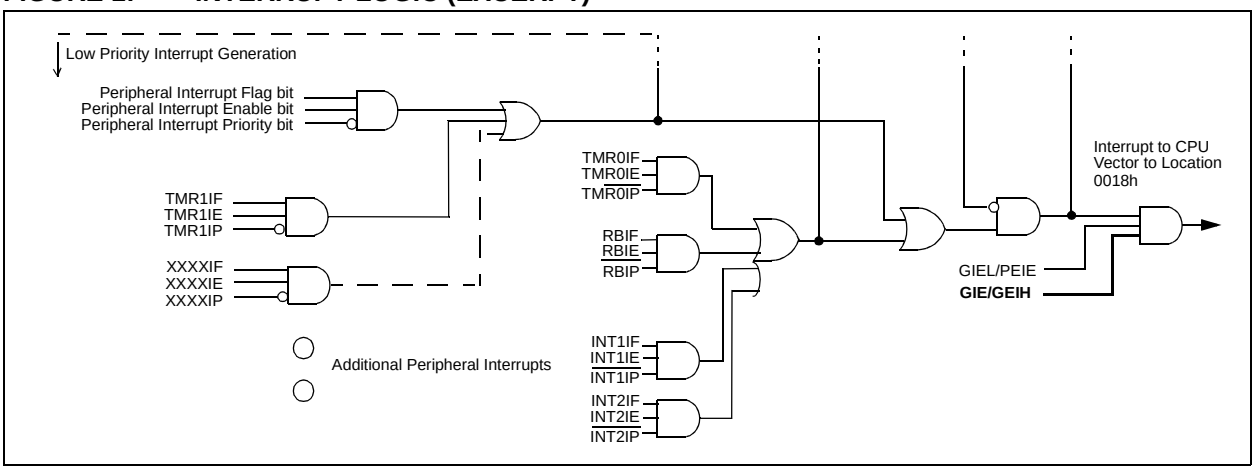
FIGURE 1: INTERRUPT LOGIC (EXCERPT)

The operation of the GIE/GIEH bit (INTCON<7>) is clarified as follows: when the bit is cleared, all interrupts are disabled. This is regardless of the state of the IPEN bit (RCON<7>), the priority of the interrupt, or whether or not the interrupt is unmasked. This varies from the original description, in which clearing the bit when IPEN = 1 would only disable high priority interrupts.

Also, the interrupt logic funnel shown in Figure 7-1 of the Device Data Sheet is amended with the addition of a GIE/GIEH control line, as shown in Figure 1 (new material in **bold line**).

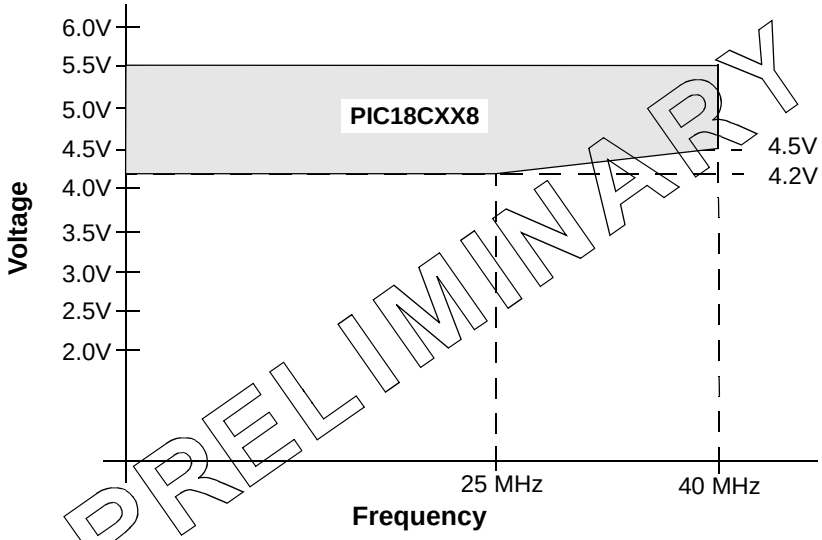
FIGURE 25-1: PIC18CXX8 VOLTAGE-FREQUENCY GRAPH (INDUSTRIAL, EXTENDED)

The operating frequency range has been updated.

The voltage vs. frequency graphs have also been updated. Figures 25-1 and 25-2 of the Device Data Sheet are replaced with the graphs shown on the following page.

FMAX = (50.0) (VDDAPPMIN – 4.2V) + 25 MHz, for 4.2V ≤ VDDAPPMIN ≤ 4.5V
FMAX = 40 MHz, for VDDAPPMIN > 4.5V

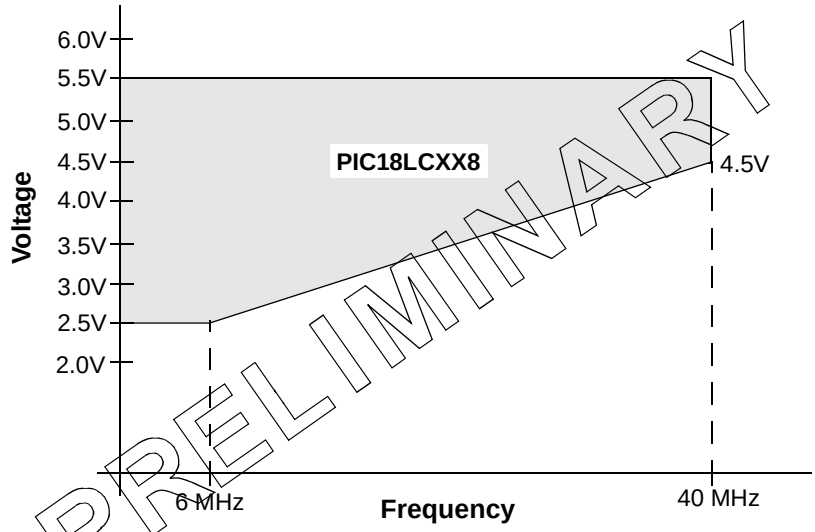
FIGURE 25-2: PIC18LCXX8 VOLTAGE-FREQUENCY GRAPH (INDUSTRIAL)

FMAX = (17.0 MHz/V) (VDDAPPMIN – 2.5V) + 6 MHz, for VDDAPPMIN ≤ 4.5V
FMAX = 40 MHz for VDDAPPMIN > 4.5V
