## MSP430F5247 Device Erratasheet

### 1 Functional Errata Revision History

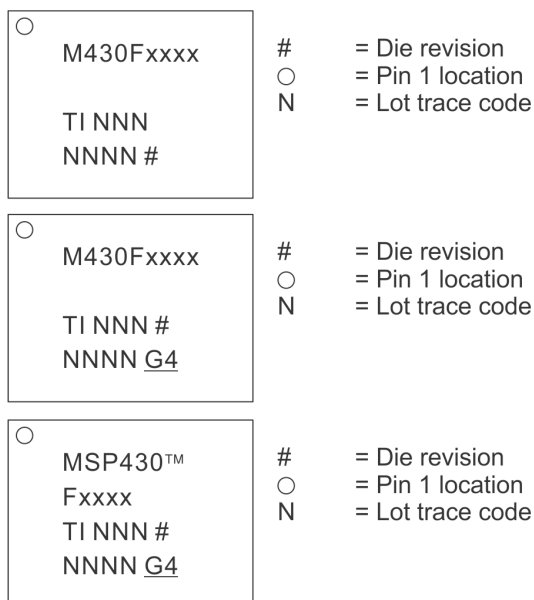
**RGC64**                      *QFN (RGC), 64 pin*

NOTE: Package marking with "TM" applies only to devices released after 2011.

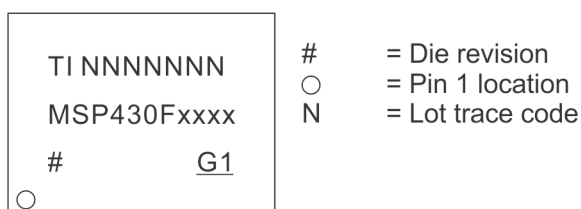
## YFF64

### DSBGA (YFF), 64 Pin

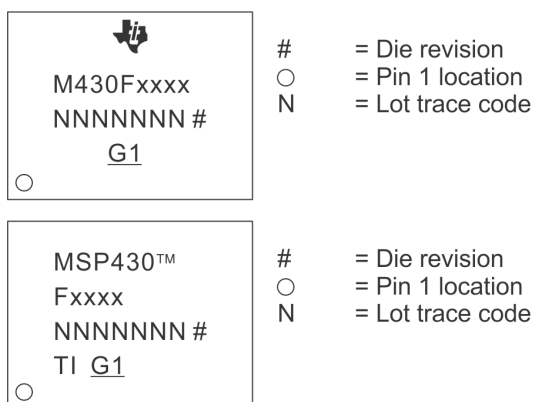
## ZQE80

### BGA (ZQE), 80 pin

NOTE: Package marking with "TM" applies only to devices released after 2011.
