## MSP430F5249 Device Erratasheet

The revision of the device can be identified by the revision letter on the [Package Markings](#) or by the [HW\\_ID](#) located inside the TLV structure of the device

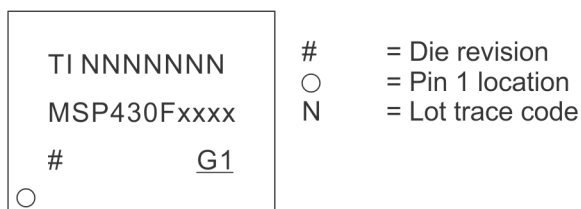
### YFF64

#### DSBGA (YFF), 64 Pin

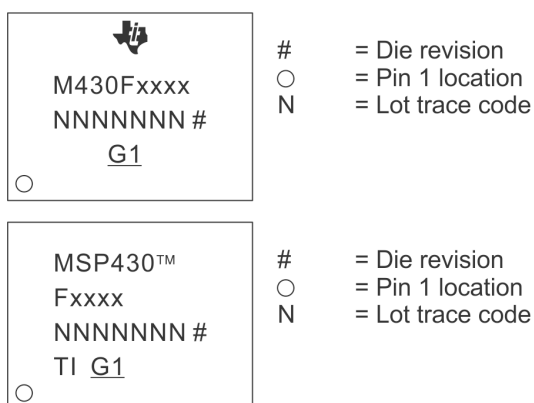
## ZQE80

### BGA (ZQE), 80 pin

NOTE: Package marking with "TM" applies only to devices released after 2011.
