PIC18F8720/8620/6720/6620 Rev. A4 Silicon/Data Sheet Errata

The PIC18F8720/8620/6720/6620 parts you have received conform functionally to the Device Data Sheet (DS39609**B**), except for the anomalies described below.

The following silicon errata apply only to PIC18F8720/8620/6720/6620 devices with these Device/Revision IDs:

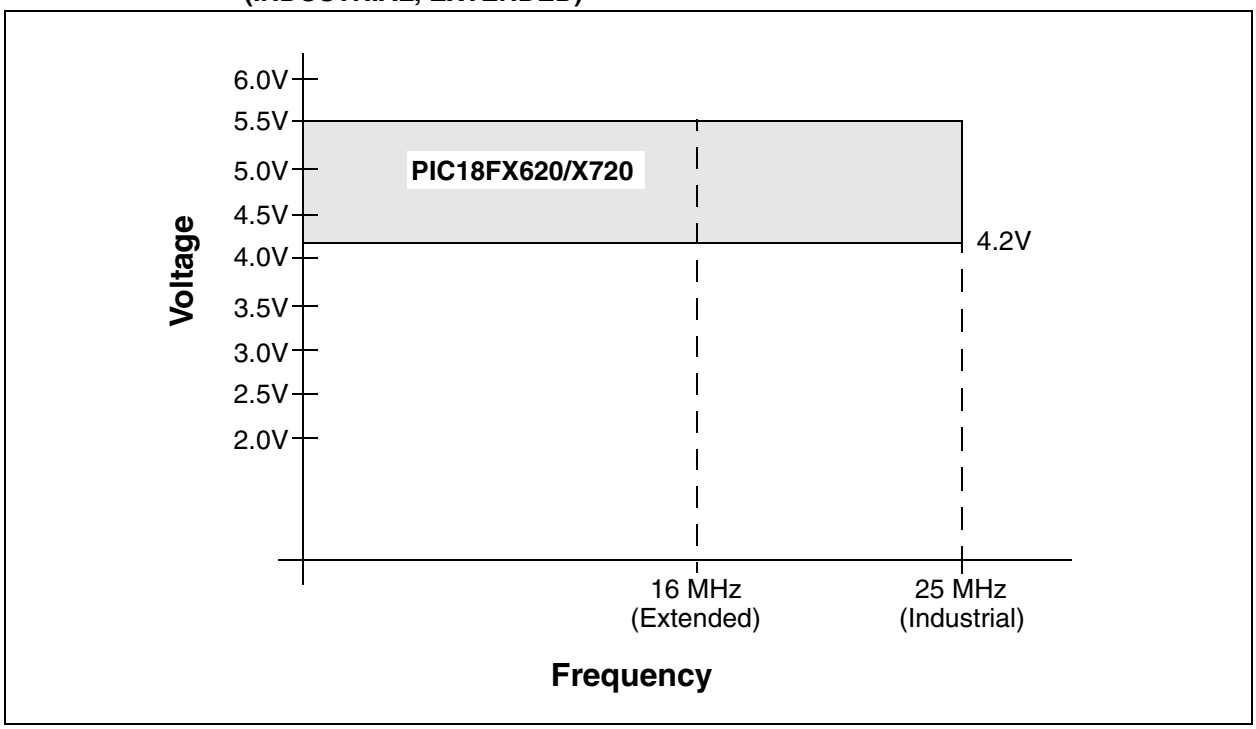
FIGURE 26-3: PIC18F6620/6720/8620/8720 VOLTAGE-FREQUENCY GRAPH (INDUSTRIAL, EXTENDED)

1. Module: Voltage-Frequency Graph

In **Section 26.0 "Electrical Characteristics"**, the following figure has been updated to clarify the voltage frequency for Extended devices.

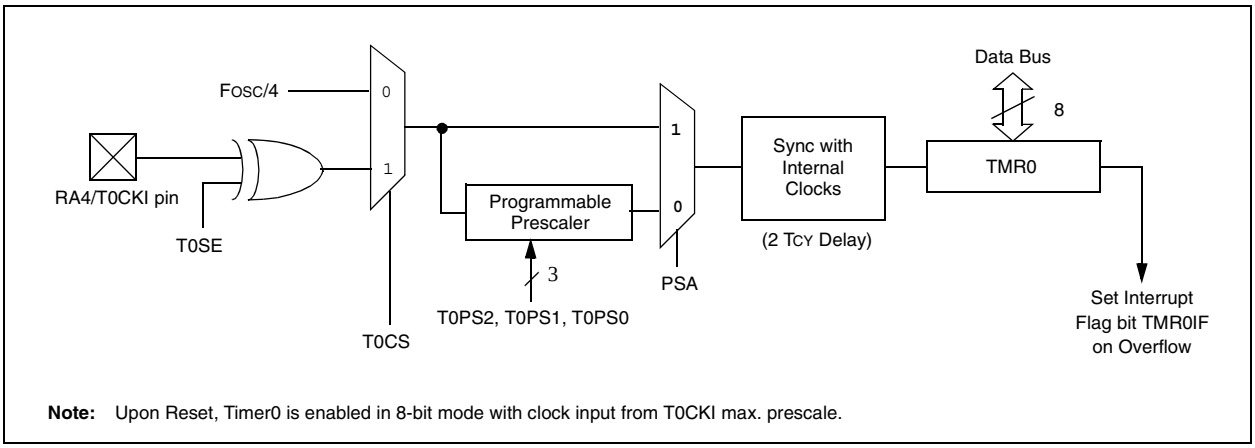
FIGURE 11-1: TIMER0 BLOCK DIAGRAM IN 8-BIT MODE

10. Module: Timer0 Block Diagram in 8-Bit and 16-Bit Modes

The PSA multiplexor bit values in Figures 11-1 and 11-2 do not match the text description of the Timer0 PSA bit in the T0CON register.

The bit values have been corrected by swapping the values as shown below (correct values are shown in **bold** text):
