## PIC24FJ256GA110 Family Silicon Errata and Data Sheet Clarification

The PIC24FJ256GA110 family devices that you have received conform functionally to the current Device Data Sheet (DS39905E), except for the anomalies described in this document.

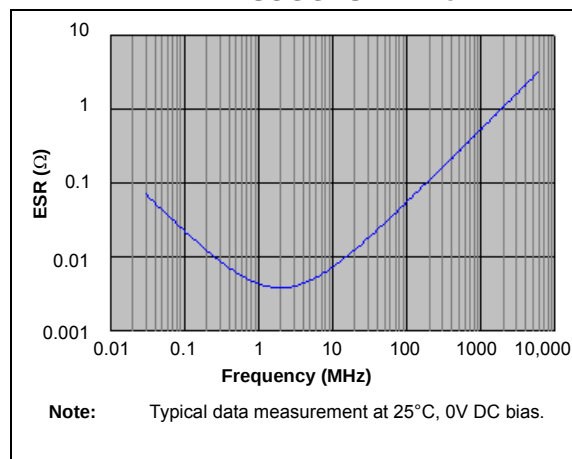
**FIGURE 2-3 FREQUENCY vs. ESR PERFORMANCE FOR SUGGESTED VCAP**

Designers may use [Figure 2-3](#) to evaluate ESR equivalence of candidate devices.

The placement of this capacitor should be close to VCAP/VDDCORE. It is recommended that the trace length not exceed 0.25 inch (6 mm). Refer to **Section 28.0 “Electrical Characteristics”** for additional information.

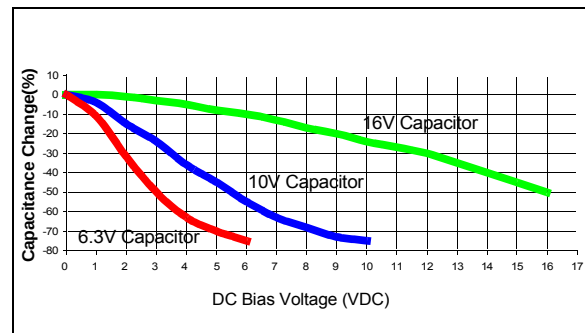
**FIGURE 2-4 DC BIAS VOLTAGE vs. CAPACITANCE CHARACTERISTICS**

A typical DC bias voltage vs. capacitance graph for 16V, 10V and 6.3V rated capacitors is shown in Figure 2-4.

When selecting a ceramic capacitor to be used with the internal voltage regulator, it is suggested to select a high-voltage rating, so that the operating voltage is a small percentage of the maximum rated capacitor voltage. For example, choose a ceramic capacitor rated at 16V for the 2.5V core voltage. Suggested capacitors are shown in Table 2-1.

The X5R and X7R capacitors typically exhibit satisfactory temperature stability (ex:  $\pm 15\%$  over a wide temperature range, but consult the manufacturer's data sheets for exact specifications). However, Y5V capacitors typically have extreme temperature tolerance specifications of  $+22\%/-82\%$ . Due to the extreme temperature tolerance, a 10  $\mu\text{F}$  nominal rated Y5V type capacitor may not deliver enough total capacitance to meet minimum internal voltage regulator stability and transient response requirements. Therefore, Y5V capacitors are not recommended for use with the internal regulator if the application must operate over a wide temperature range.
