## PIC24FJ256GB110 Family Silicon Errata and Data Sheet Clarification

The PIC24FJ256GB110 family devices that you have received conform functionally to the current Device Data Sheet (DS39897C), except for the anomalies described in this document.

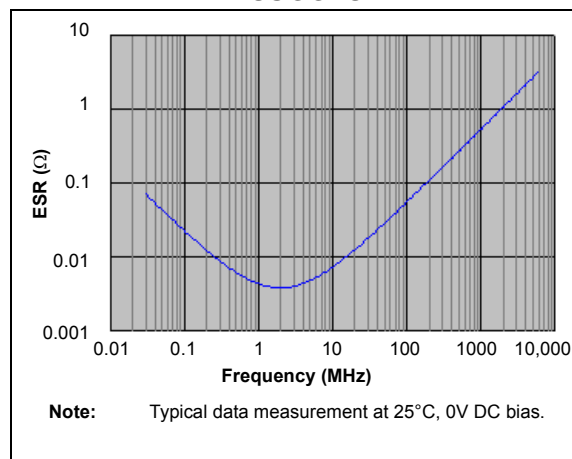
**FIGURE 2-3 FREQUENCY vs. ESR PERFORMANCE FOR SUGGESTED VCAP**

Designers may use [Figure 2-3](#) to evaluate ESR equivalence of candidate devices.

The placement of this capacitor should be close to VCAP/VDDCORE. It is recommended that the trace length not exceed 0.25 inch (6 mm). Refer to **Section 29.0 “Electrical Characteristics”** for additional information.

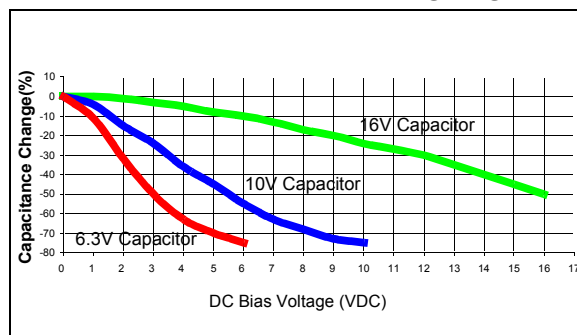
**FIGURE 2-4 DC BIAS VOLTAGE vs. CAPACITANCE CHARACTERISTICS**

A typical DC bias voltage vs. capacitance graph for 16V, 10V and 6.3V rated capacitors is shown in Figure 2-4.

When selecting a ceramic capacitor to be used with the internal voltage regulator, it is suggested to select a high-voltage rating, so that the operating voltage is a small percentage of the maximum rated capacitor voltage. For example, choose a ceramic capacitor rated at 16V for the 2.5V core voltage. Suggested capacitors are shown in Table 2-1.
