**TMS320LF2407A, TMS320LF2406A, TMS320LF2403A,  
TMS320LF2402A DSP Controllers  
Silicon Errata**

*SPRZ002E*  
July 2001  
Revised July 2004

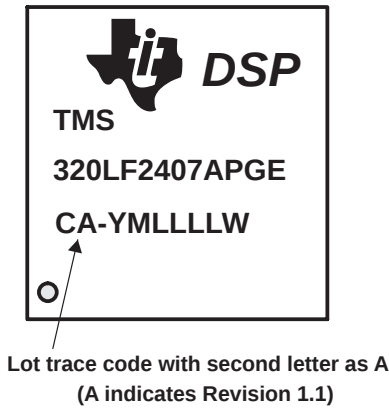
Figure 1. Example, Lot Trace Code for TMS320LF2407A (PGE)

The device revision can be determined by the lot trace code marked on the top of the package. The location of the lot trace code for the PGE package is shown in Figure 1.
