## Introduction

Thank you for designing with the Xilinx Defense-Grade Zynq®-7000Q family of devices. Although Xilinx has made every effort to ensure the highest possible quality, the devices listed in [Table 1](#) are subject to the limitations described in the following errata.

## Processor System (PS) Errata Details

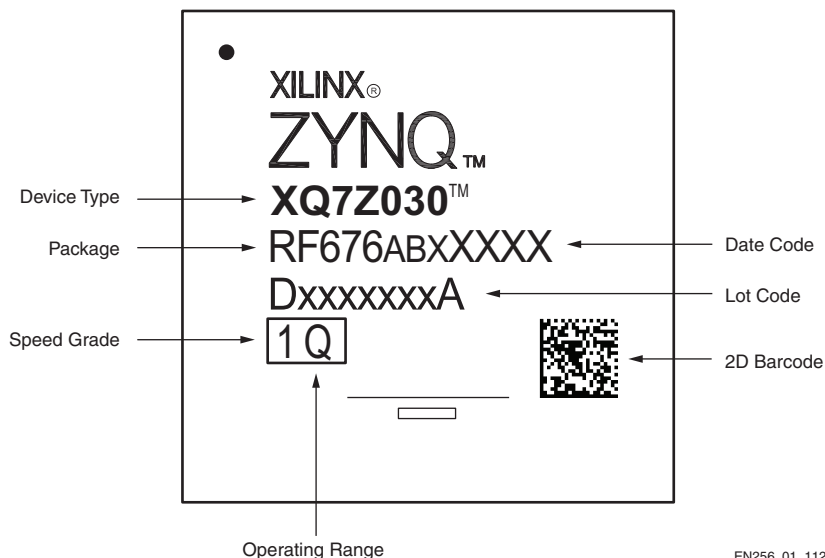
Figure 1: Example Device Top Mark

Figure 1 shows an example device top mark for the device listed in Table 1. Refer to [XCN16014](#) for details on the addition of the 2D barcode.

| Date | Version | Description of Revisions |
|---|---|---|
| 12/16/2016 | 1.5 | Updated <a href="#">Figure 1</a> with 2D barcode. |
