*RM46x Microcontroller*

**Silicon Revision A**

# **Silicon Errata**

Literature Number: SPNZ187  
September 2012

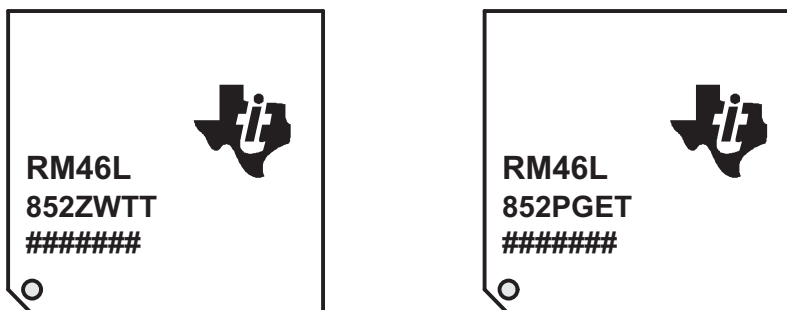
**Figure 1. Part Marking**

[Figure 1](#) provides examples of the RM46Lx device markings.
