**TMS320VC5409A**  
**Digital Signal Processor**  
**Silicon Errata**

SPRZ186C  
June 2001  
Revised May 2003

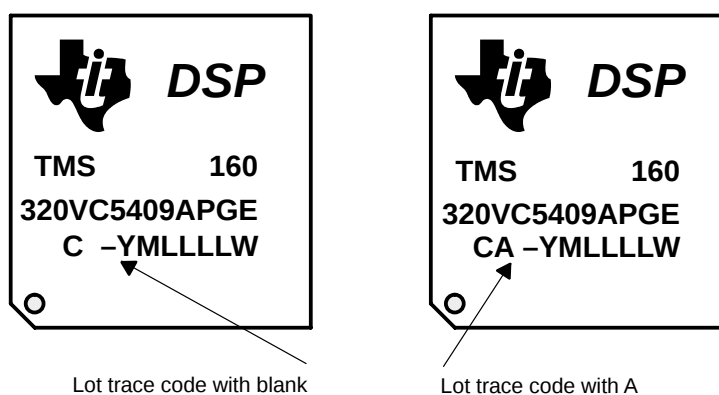
**Figure 1. Example, Typical Lot Trace Code for TMS320VC5409A DSP (PGE)**

The device revision can be determined by the lot trace code marked on the top of the package. The locations for the lot trace codes for the PGE and the GGU packages are shown in Figure 1 and Figure 2, respectively.

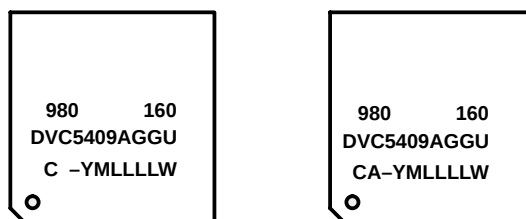
NOTE: Qualified devices in the PGE package are marked with the letters "TMS" at the beginning of the device name, while nonqualified devices in the PGE package are marked with the letters "TMX" or "TMP" at the beginning of the device name. Similarly, qualified devices in the GGU package are marked with the letters "DV" at the beginning of the device name, and nonqualified devices in the GGU package are marked with the letters "XDV" or "PDV" at the beginning of the device name.

**Figure 2. Example, Typical Lot Trace Code for TMS320VC5409A DSP (GGU)**
