# **CC1310 SimpleLink™ Ultra-Low-Power Sub-1 GHz Wireless MCU Silicon Revisions B, A**

This document describes the known exceptions to functional specifications (advisories) for the CC1310 SimpleLink™ device.

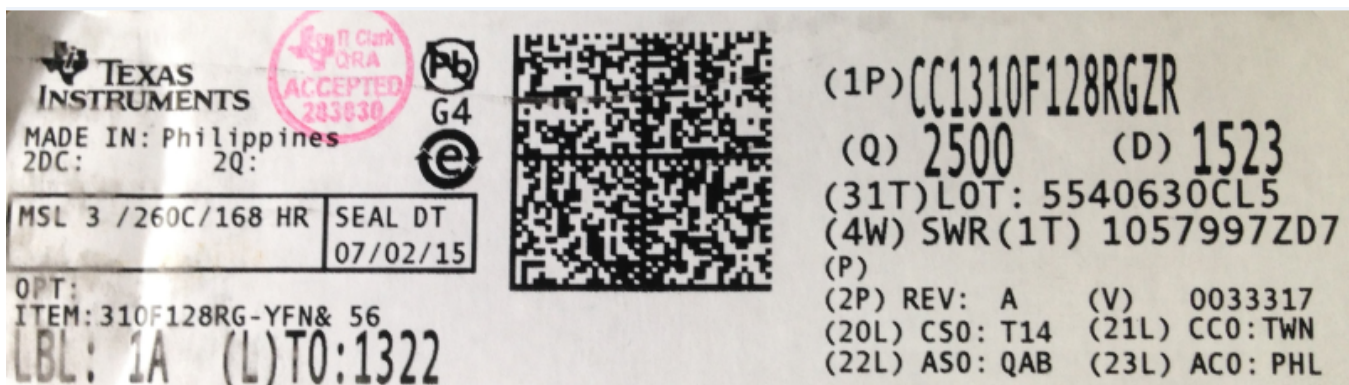
Figure 3. Sample Product Shipping Label for CC1310 Device

- Package label:
  - The die revision name is shown on the tape and reel label as shown in the example label in Figure 3.
  - Entry (2P) lists the revision (either A or B).
