**TMS320VC5410A**  
**Digital Signal Processor**  
**Silicon Errata**

SPRZ187B  
June 2001  
Revised July 2002

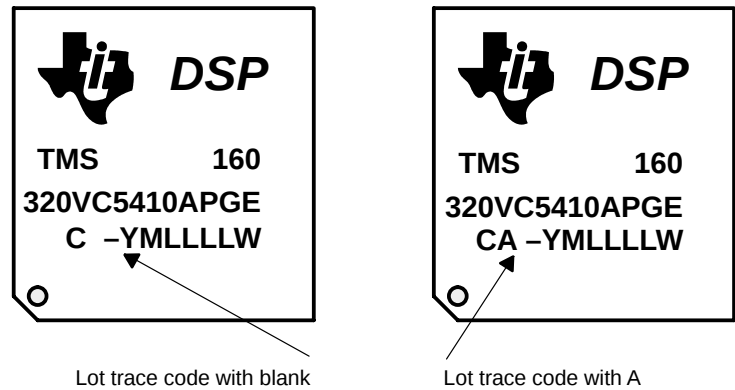
Figure 1. Example, Typical Lot Trace Code for TMS320VC5410A DSP (PGE)

The device revision can be determined by the lot trace code marked on the top of the package. The location for the lot trace codes for the PGE and the GGU packages are shown in Figure 1 and Figure 2, respectively.

| Lot Trace Code | Silicon Revision | Comments |
| Blank<br>(no second letter in prefix) | Initial Silicon | |
| A<br>(second letter in prefix is A) | Indicates Revision A Silicon | |
| B<br>(second letter in prefix is B) | Indicates Revision B Silicon | |

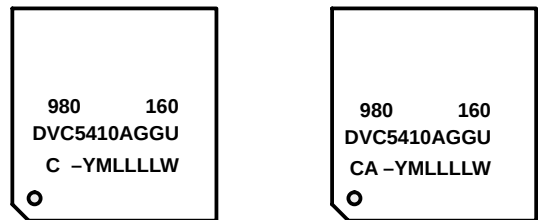
Figure 2. Example, Typical Lot Trace Code for TMS320VC5410A DSP (GGU)

NOTE: Qualified devices in the PGE package are marked with the letters “TMS” at the beginning of the device name, while nonqualified devices in the PGE package are marked with the letters “TMX” or “TMP” at the beginning of the device name. Similarly, qualified devices in the GGU package are marked with the letters “DV” at the beginning of the device name, and nonqualified devices in the GGU package are marked with the letters “XDV” or “PDV” at the beginning of the device name.
