Chip Errata for the i.MX RT1060

This document details the silicon errata known at the time of publication for the i.MX RT1060 crossover processors.

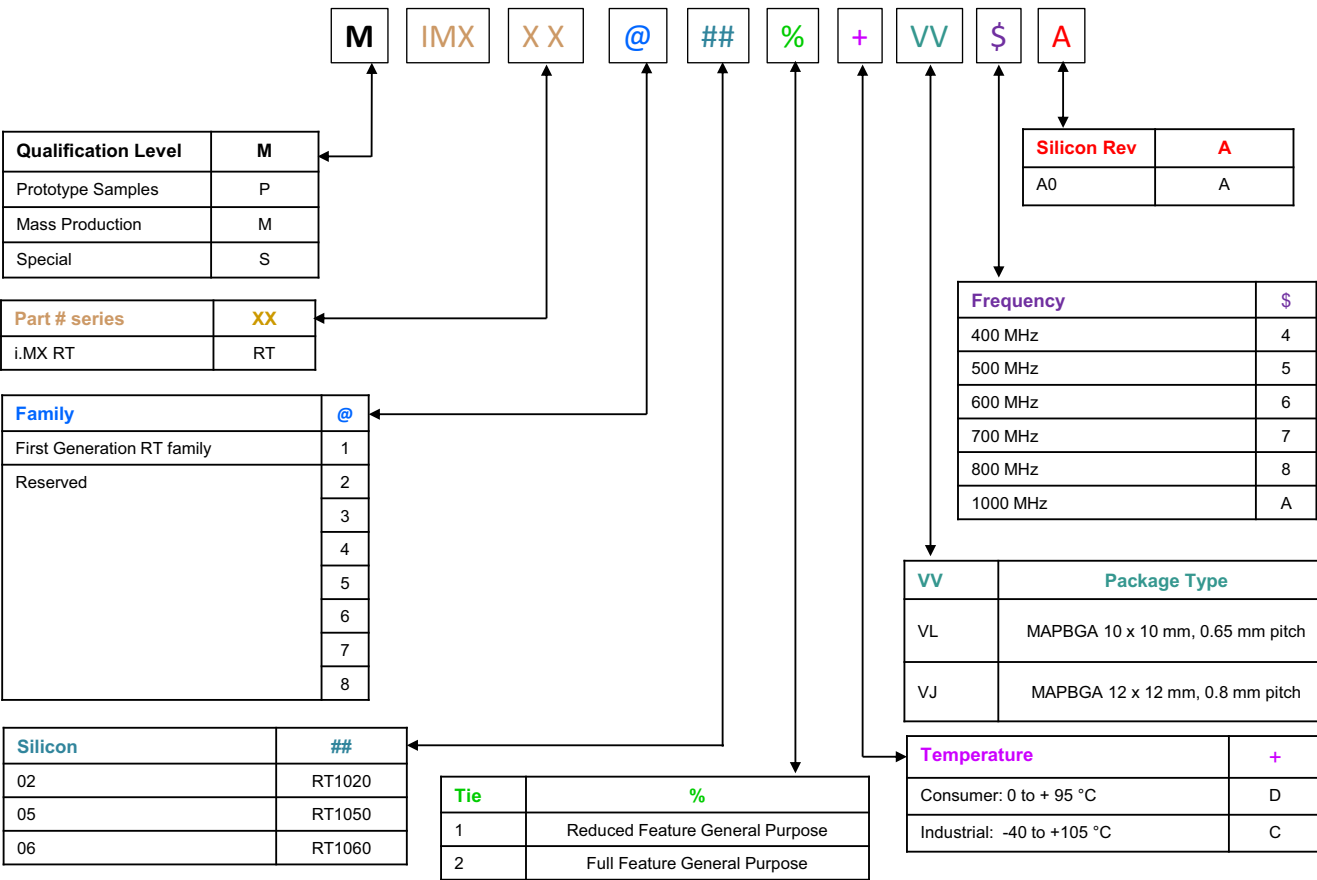
Figure 1. Revision Level to Part Marking Cross-Reference

Figure 1 provides a cross-reference to match the revision code to the revision level marked on the device.
