IWR1443 Device Errata

Silicon Revision 1.0, 2.0, and 3.0

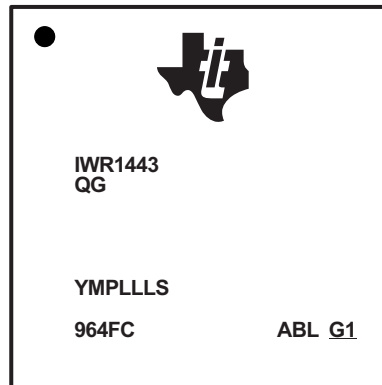
Figure 1. Example of Device Part Markings

Figure 1 shows an example of the IWR1443 Radar Device's package symbolization.

This identifying number contains the following information:

- **Line 1:** Device Number
- **Line 2:** Temperature and Security Grade
- **Line 3:** Lot Trace Code
 - YM = Year/Month Code
 - PLLL = Assembly Lot
 - S = Assembly Site Code
- **Line 4:**
 - 964 = IWR1443 Identifier
 - D = ES2.0
 - FC = ES3.0
 - BLANK = ES1.0
 - ABL = Package Identifier
 - G1 = "Green" Package Build (must be underlined)
