## **AWR1642 Device Errata**

This document describes the known exceptions to the functional and performance specifications to TI CMOS Radar Devices (AWR1642).

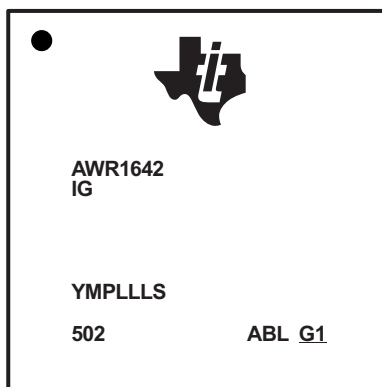
Figure 1. Example of Device Part Markings

Figure 1 shows an example of the AWR1642 Radar Device's package symbolization.

This identifying number contains the following information:

- **Line 1:** Device Number
- **Line 2:** Temperature and Security Grade
- **Line 3:** Lot Trace Code
  - YM = Year/Month Code
  - PLLL = Assembly Lot
  - S = Assembly Site Code
- **Line 4:**
  - 502 = AWR1642 Identifier
  - ABL = Package Identifier
  - G1 = "Green" Package Build (must be underlined)
