## ***IWR1642 Device Errata***

This document describes the known exceptions to the functional and performance specifications to TI CMOS Radar Devices (IWR1642).

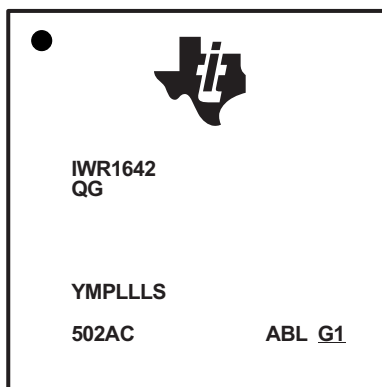
Figure 1. Example of Device Part Markings

Figure 1 shows an example of the IWR1642 Radar Device's package symbolization.

This identifying number contains the following information:

- **Line 1:** Device Number
- **Line 2:** Temperature and Security Grade
- **Line 3:** Lot Trace Code
  - YM = Year/Month Code
  - PLLL = Assembly Lot
  - S = Assembly Site Code
- **Line 4:**
  - 502AC = IWR1642 Identifier
  - ABL = Package Identifier
  - G1 = "Green" Package Build (must be underlined)
