PIC24FJ128GA310 Family Silicon Errata and Data Sheet Clarification

The PIC24FJ128GA310 family devices that you have received conform functionally to the current Device Data Sheet (DS30009996G), except for the anomalies described in this document.

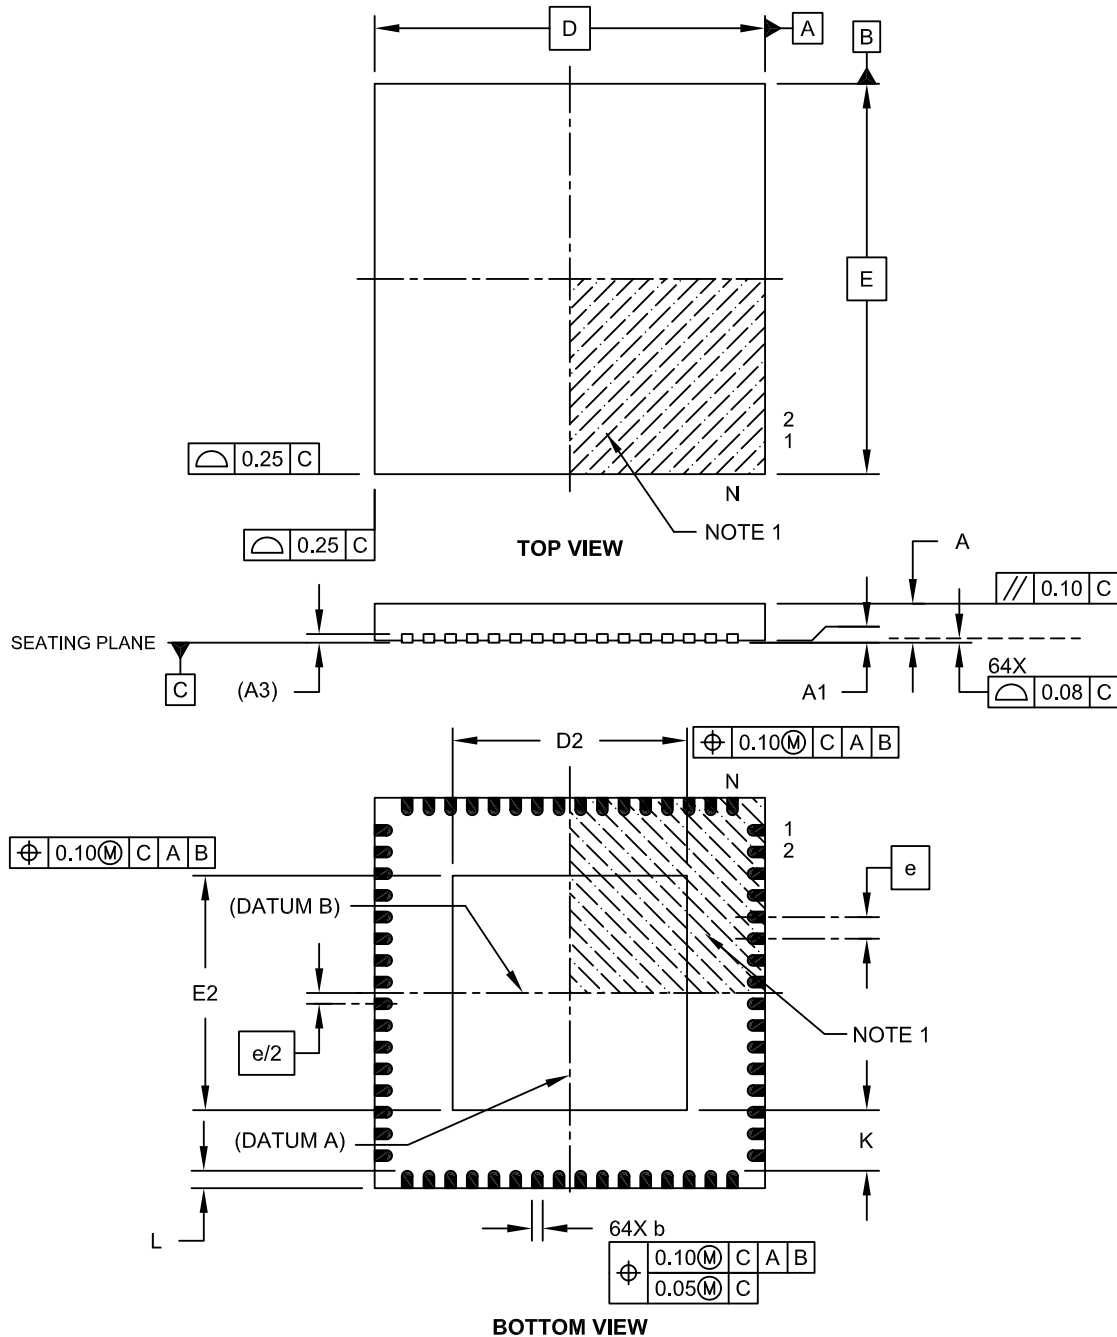
64-Lead Plastic Quad Flat, No Lead Package (MR) – 9x9x0.9 mm Body with 5.40 x 5.40 Exposed Pad [QFN]

The 64-Lead Plastic Quad Flat, No Lead Package (MR) drawings on Pages 391 through 393 have been replaced with the C04-154A package drawings shown below.

Note 2: It is recommended to connect the metal pad on the bottom of the 64-pin QFN package to Vss.

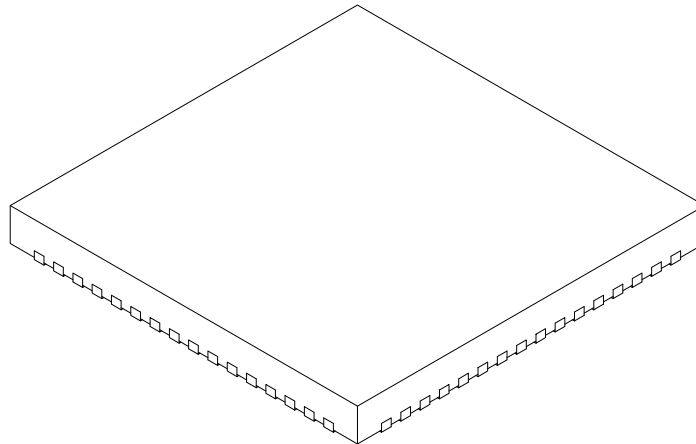
64-Lead Plastic Quad Flat, No Lead Package (MR) – 9x9x0.9 mm Body with 5.40 x 5.40 Exposed Pad [QFN]

Units		MILLIMETERS		
Dimension Limits		MIN	NOM	MAX
Number of Pins	N	64		
Pitch	e	0.50 BSC		
Overall Height	A	0.80	0.90	1.00
Standoff	A1	0.00	0.02	0.05
Contact Thickness	A3	0.20 REF		
Overall Width	E	9.00 BSC		
Exposed Pad Width	E2	5.30	5.40	5.50
Overall Length	D	9.00 BSC		
Exposed Pad Length	D2	5.30	5.40	5.50
Contact Width	b	0.20	0.25	0.30
Contact Length	L	0.30	0.40	0.50
Contact-to-Exposed Pad	K	0.20	-	-

1. Pin 1 visual index feature may vary, but must be located within the hatched area.
2. Package is saw singulated.
3. Dimensioning and tolerancing per ASME Y14.5M.

Microchip Technology Drawing C04-154A Sheet 2 of 2
