# IT3 Thermal Cycling Test Report (Solder type: Sn63 Pb37)

**Hirose Electric Co., Ltd.**

The following test report is to be considered official documentation for results found during thermal cycle testing of the IT3 series BGA connector system. BGA connection is becoming a key technology for current and next generation high-speed transmission. It is crucial to perform accelerated life time testing to both simulate actual applications and prove BGA attachment reliability. All processes described herein, including test board design and thermal cycling test conditions, are based on and conform to IPC-9701.

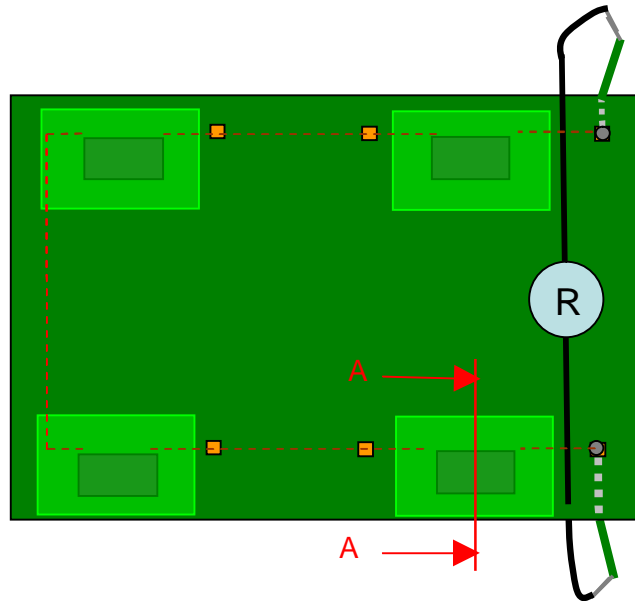
**Cross section \_ AA**

Final assembly, including mounting interposer assembly / daughter cards and board spacers, was performed to complete the daisy-chain circuit prior to performing the continuity check.

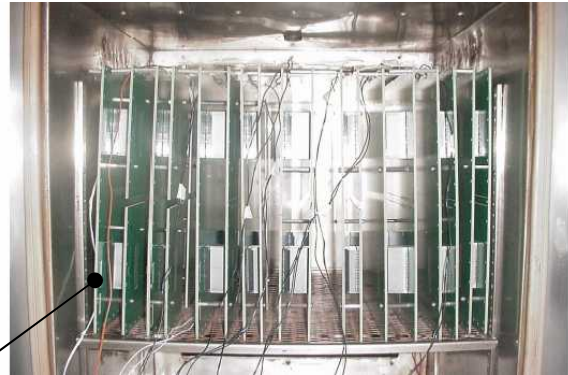
**Thermocouple Locations**

IT3-assembled test board  
(Refer to 4.2.2 Test board example for test board details.)

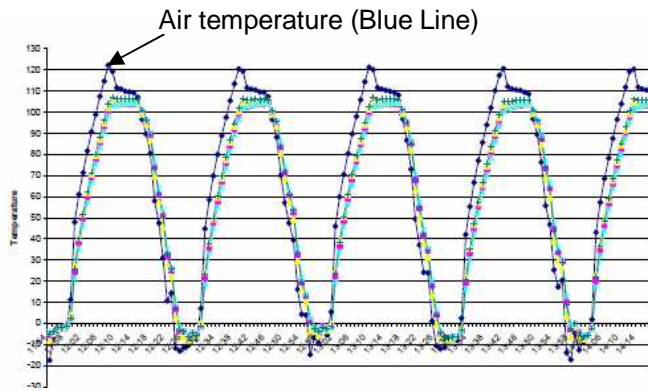
**Chamber 1 TL 544**

**Measured Thermal Cycle Profile**
