# MM912F634, Silicon Analog Mask (M91W) / Digital Mask (M33G) Errata

This mask set errata applies to the Analog mask M91W for these products:

Document Number: MM912F634ER  
Rev. 8.0  
6/2015

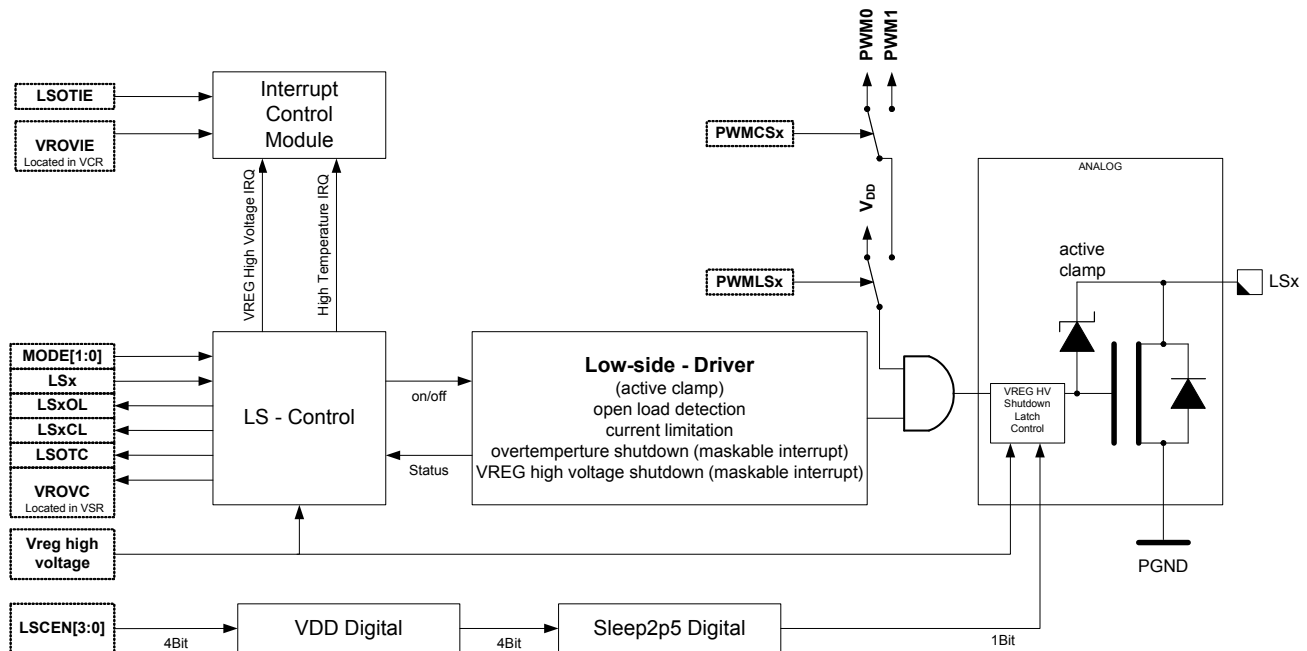
Figure 1. Low-side Block Diagram

The Low-side Control Enable (LSCEN) register is reset only after LVR, LVRX and POR. It is also supposed to reset in case of an VREG Over-voltage event. See [Figure 1](#).

A digital implementation issue prevents the LSCEN register from resetting in case of a VREG high voltage condition. This register was implemented to create a secondary deactivation stage for the Low-side drives, verifying the VDD-Digital and the Sleep2p5 Digital circuitry is functional after a VREG high voltage.

The Shutdown of the LS drivers is still established via the VREG OVERVOLTAGE FLAG and has to be acknowledged by the Software (IRQ optional).

The basic intention of the feature is still present as a functional VDD-Digital and the Sleep2p5 Digital circuitry is still required for the LS to be active. Other than specified, the register will not reset in case of a high-voltage condition and therefore would not need to be written to reactivate the Low-side drivers.

This feature is listed for correction in case of future mask corrections. It is recommended to maintain the register write LSCEN=0x5 to re-enable the Low-side drivers to assure software compatibility with the potential silicon fix.

Other than that, the intended security function of the feature is still in place.

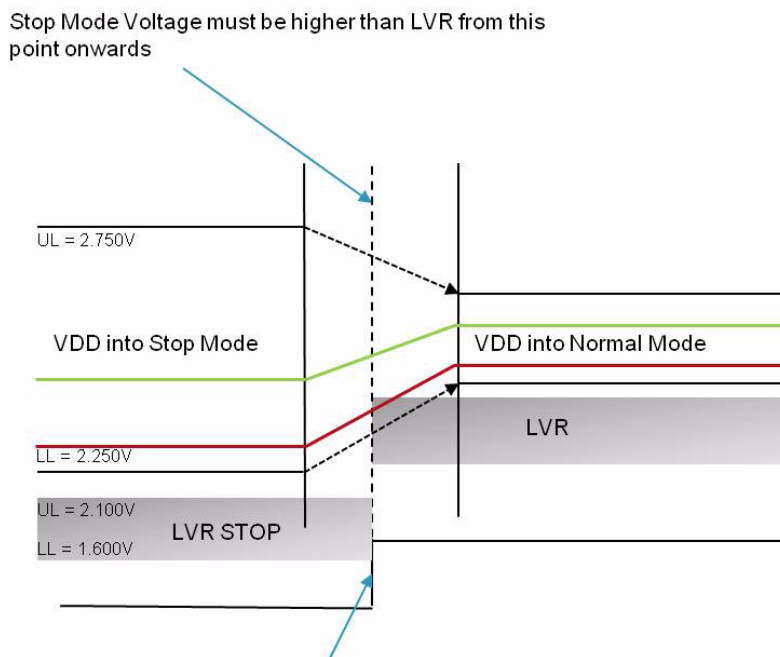
**Figure 2. Stop mode to Normal mode Transition**

After a transition from Stop mode to Normal mode due to a wake up event, the device may generate a Reset.

This behavior will affect parts with VDD in stop mode below LVR in normal mode.

When a wake-up event occurs, the transition from stop mode to normal mode is started. The VDD stop regulator is switched to VDD normal regulator. The LVR normal mode is activated. In case the actual VDD regulator output voltage is below LVR normal, the device will generate a reset on RESETA pin.

When an LVR condition on VDD occurs during a transition from Low Power to Normal, a RESET is performed and WUR bit is set into RSR register. This is the standard behavior during wake-up from sleep mode.

**NOTE:** The green line denotes a part that does not show this behavior. The red lines denotes a part that does show this behavior. The VDD parameter in Stop mode is distributed between 2.25 V and 2.75 V, while the LVR Normal is max 2.40 V. Only devices that have an actual VDD stop between 2.25 V and 2.40 V will exhibit this behavior.

There is no workaround possible to prevent the occurrence of this behavior.

The software recommendation to help minimize impact of the behavior consists in verification of the reset source after a wake-up.

This check might be performed after return from reset sequence. In case a reset has occurred, the following flag will be as described below:
